TRUCK MEDIUM MC2 (UNIMOG) ALL TYPES
WATER PUMP JOCKEY PULLEY BRACKET

MODIFICATION INSTRUCTION

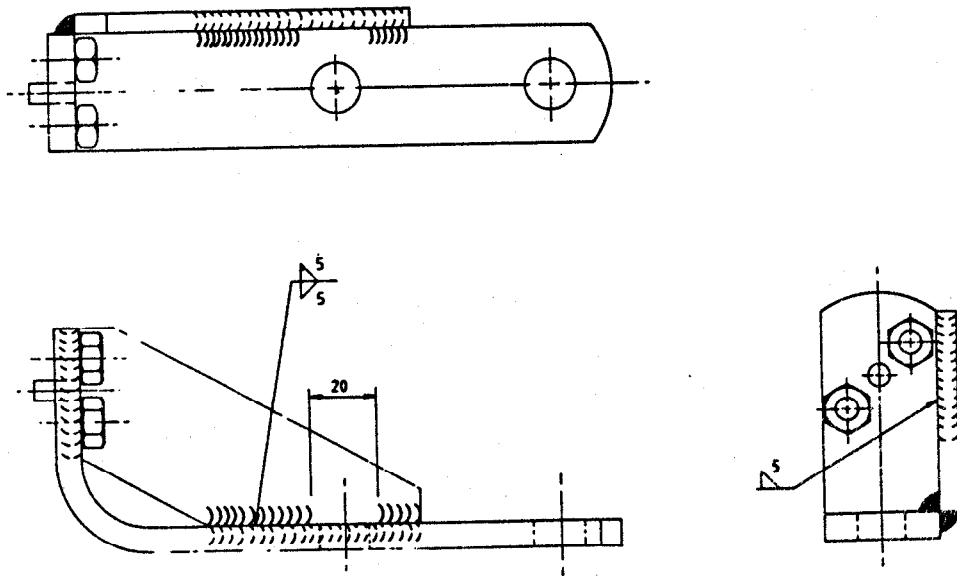
FIG 1 - BASIC BRACKET WELDING

1. Breakage of the subject pulley bracket has continued even after the additional welding detailed in VEH G 617-5. This instruction details the fitting of an additional gusset to the pulley bracket and, combined with the reduced alternator output (VEH G 619-11 refers), should eliminate further breakages.

8. Remove the pulley bracket from the engine and proceed as follows:
 - a. Inspect the bracket for cracks and that all welding conforms to Fig 1.
 - b. Weld if required in accordance with WKSP B 010.
 - c. Manufacture a gusset as shown in Fig 2 using item 2, Table 1.
 - d. Fit and weld the gusset to the bracket as shown in Fig 3.
 - e. Paint the bracket in accordance with WKSP B 700.
 - f. Refit the bracket and adjust belt tension in accordance with VEH G 603.
