TRUCK MEDIUM MC2 UNIMOG-ALL TYPES

BRAKE AIRLINE CHAFING

MODIFICATION INSTRUCTION

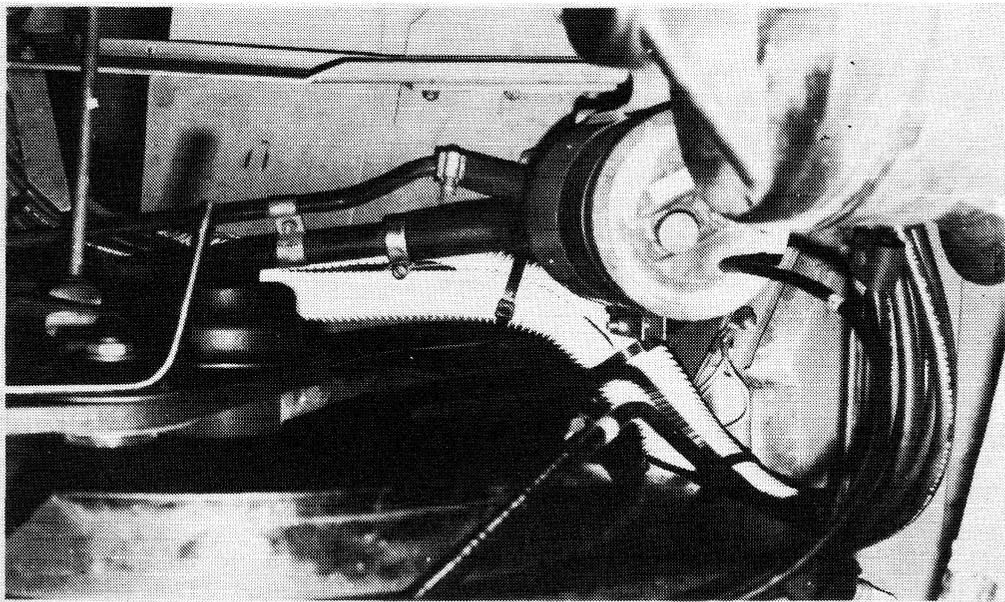
FIG 1 - COMPLETED MODIFICATION

1. This instruction details the fitting of a plastic protective sleeve over the brake airlines in the engine bay to prevent chafing on the chassis rail and radiator mount.

8. To complete the modification proceed as follows:
 - a. Remove existing plastic ties holding the brakelines to the lower radiator mount.
 - b. Ensure that the lines are positioned above the radiator mount.
 - c. Cut the plastic tubing (item 1, Table 1) along its length and place it over the airlines.
 - d. Secure the plastic tubing to the airlines and the radiator mount using the plastic ties (item 2, Table 1) as shown in Fig 2.
