TRUCK MEDIUM MC2 (UNIMOG) - ALL CARGO VARIANTS
TRAY FLOOR HEADBOARD ASSEMBLY

MODIFICATION INSTRUCTION

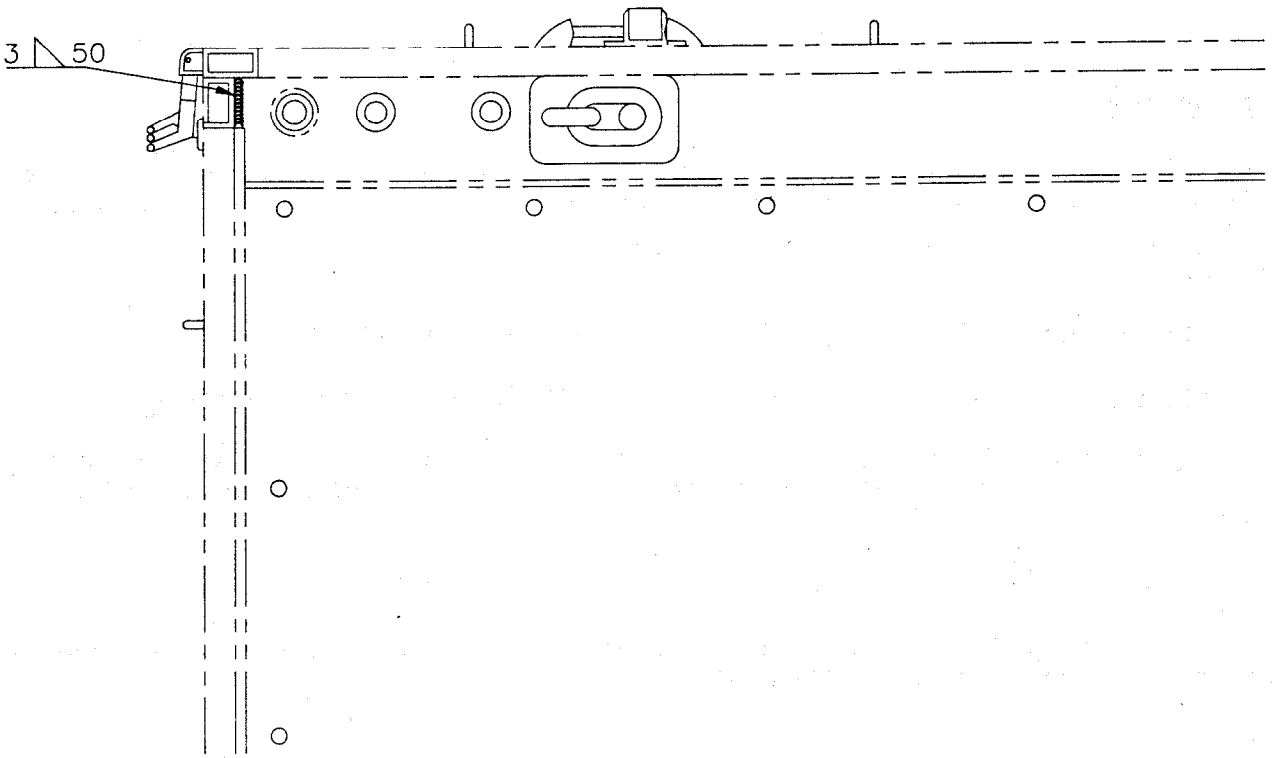
FIG 1 - WELDING DETAILS

1. This instruction details additional welding to the vertical posts on either side of the headboard to strengthen and prevent cracking of the existing welds.

7. To carry out the modification proceed as follows:
 - a. Clean the area where the vertical posts meet the tray floor.
 - b. Weld both the right and left hand posts as shown in Fig 1, using NSN 3439-66-016-2218 Electrode Welding 2.5mm.
 - c. Repair any cracked welds in accordance with WKSP B 002-1.
 - d. Paint all exposed areas as detailed in WKSP B 700.
8. Modification Record Plate. On completion of the modification, deface the numeral 21 on the vehicle modification record plate.
