TRUCK, UTILITY, LIGHTWEIGHT, MC2 - LAND ROVER 110 4X4

TRUCK, CARGO, LIGHT, MC2 - LAND ROVER 110 6X6

FITTING OF LINK CABLE TO THE HEADLAMP ELECTRICAL CIRCUIT

MODIFICATION INSTRUCTION

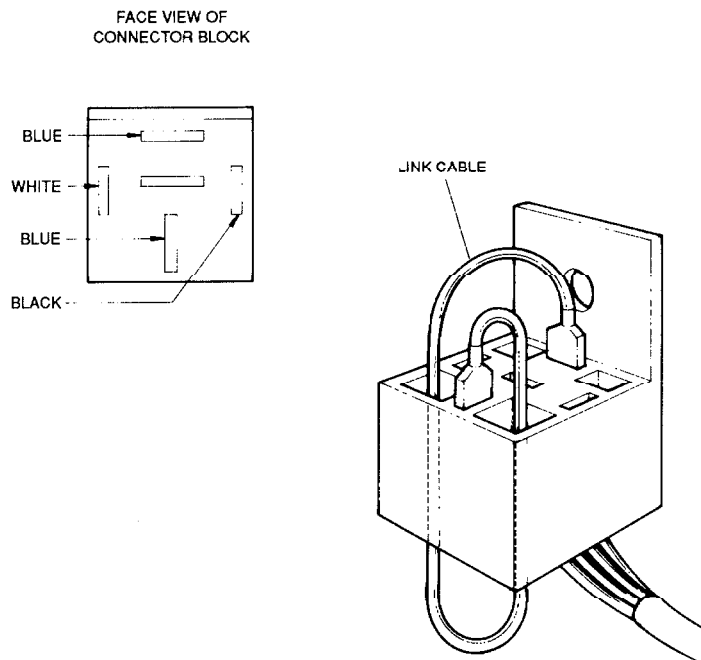
FIG 1 - LINK FITMENT

1. This instruction details the removal of the headlight over-ride relay and the fitment of a link cable to the headlight over-ride relay connector block to allow the operation of the headlights with the ignition in the 'off' position. The purpose of the modification is to correct a build error by Land Rover Australia and this instruction details the retrofit of those vehicles not rectified in production.

1. Ensure that the link wire is installed correctly otherwise wire burnout will occur.

- c. Turn the ignition and headlight switches to the 'off' position and disconnect the battery terminals.
- d. Fit the link cable (item 1 from Table 1) to the two blue wires as shown in Fig 1, ensuring that the cable is threaded through the block to prevent accidental dislodgement.
