TRUCK, UTILITY, LIGHTWEIGHT, MC 2 - LAND ROVER 110 - ALL TYPES
TRUCK, CARGO, LIGHT, MC 2 - LAND ROVER 110 - ALL TYPES

FITTING OF INSTRUMENT BLACKOUT COVER

MODIFICATION INSTRUCTION

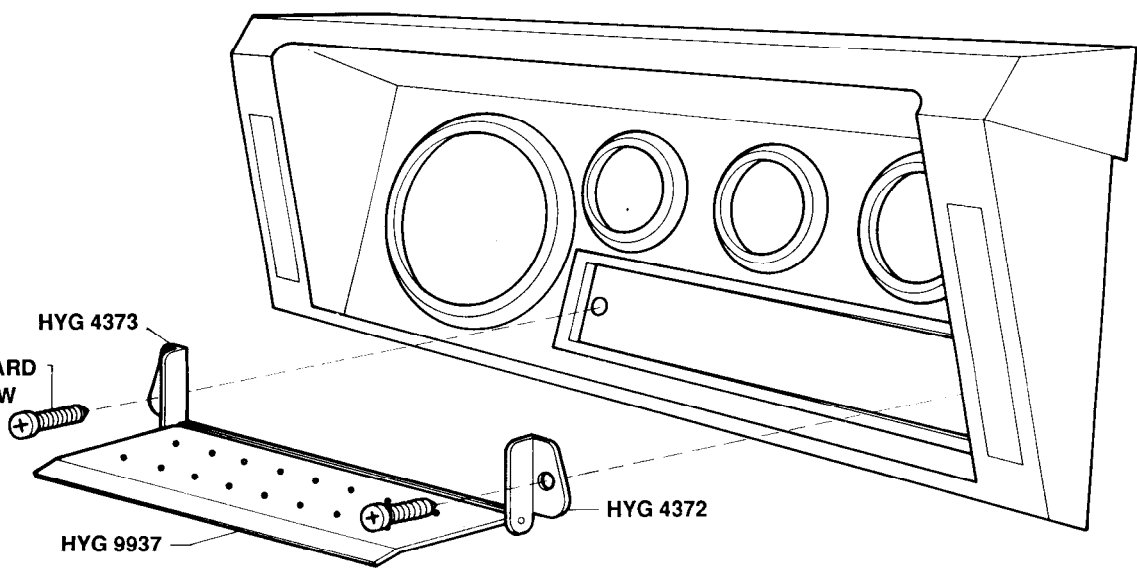
FIG 1 - INSTRUMENT BLACKOUT COVER

1. This instruction details the fitting of an instrument panel blackout cover, so as to minimize the light emitted from the instrument warning lights during night driving and where Night Vision Goggles (NVG) are used for operational driver training.

7. The modification is to be completed in the sequence as described below:
 - a. Remove the existing instrument warning light panel retaining screws, whilst maintaining light finger pressure on the panel to ensure correct location.
 - b. Using the existing screws, secure the blackout cover and brackets (Items 1 from Table 1) into position as shown in Fig 1.
