TRUCK, LIGHTWEIGHT AND TRUCK, LIGHT – ALL TYPES – LAND ROVER 110 4X4 AND 6X6

RECTIFICATION OF RADIUS ARM MOUNTS ON FRONT AXLE HOUSING

MISCELLANEOUS INSTRUCTION

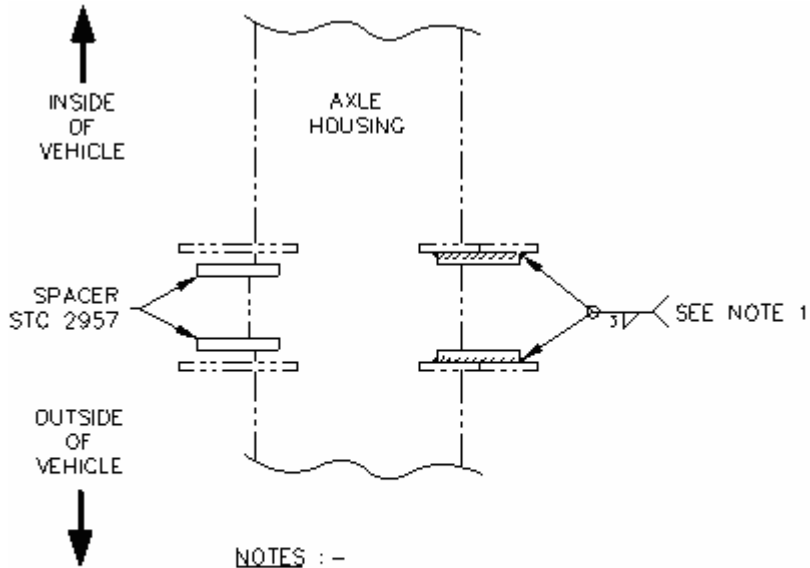
Figure 1 Adding Spacers to Radius Arm Mounts

3. Whilst in service, both types of axle housing (i.e. with wide and narrow type radius arm mounting brackets) have had wear detected in the mounting bracket locating plate holes. This wear has caused the holes to elongate. EMEI Vehicle G 189-11, EMEI Vehicle G 104-1, and EMEI Vehicle G 204-1 authorise a reclamation process to weld a collar and a locknut to the mounting bracket plates in order to prolong axle life. These EMEI limit reclamation to narrow type axle housings.

- b. Remove all surface protection coatings from the repair area for a distance of 25 mm in all directions, using either a grinder, sander or file.
- c. Fit Items 1 and 2 from Table 1 to the axle assembly mounts, as shown in Figure 1, using the bolt to align the holes in the spacer with the holes in the locating plates. Clamp the spacers in position against the inside surface of the locating plates and remove the bolt.

- d. Tack weld the spacers in position using the consumables specified in Para 15.f.
- e. Remove the clamps.
- f. Weld the spacers to the inside surfaces of the mount plates, as shown in Figure 1, with a 3 mm continuous fillet weld using either of the following processes:
 - (1) the manual metal arc welding (MMAW) process using electrodes that conform to AS/NZS 4855: E4819; or
 - (2) the gas metal arc welding (GMAW) process using consumables that conform to AS/NZS 2717.1: ES6-GC/M-W503AH and using shielding gas that conforms to AS 4882:SG-ACO-16/2.75.
- g. If the radius arm mounts have been previously reclaimed by welding a collar and nut to the outside of the locating plates (Figure 2), remove them using a grinder. Take care not to remove parent metal from the locating plates.

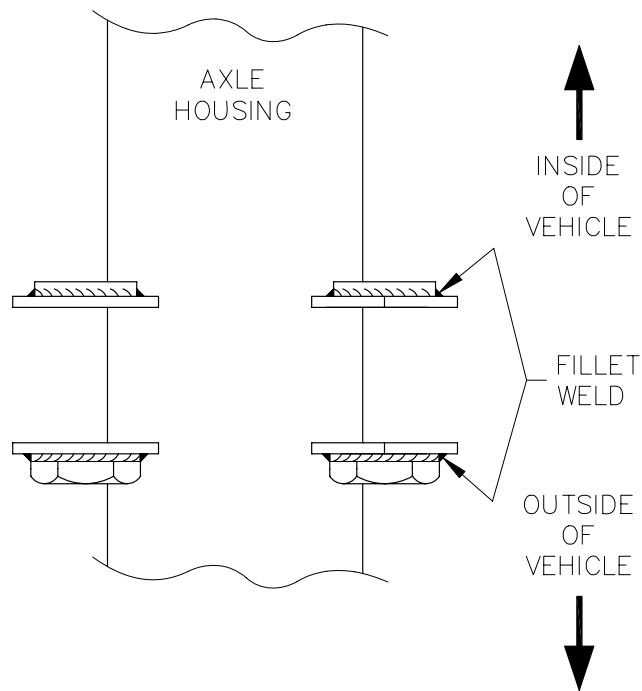
Figure 2 Radius Arm Mounts Showing Previous Reclamation Work to be Removed

Ensure any collars and nuts that have been welded to the outside of the locating plates, as part of previous reclamation work, are removed.
