TRUCK, UTILITY, LIGHTWEIGHT, MC2 LAND ROVER 110 - ALL TYPES

REPLACEMENT OF THE MAPLIGHT SECURING CLIP
AND SECURING OF THE MAPLIGHT WIRING

MODIFICATION INSTRUCTION

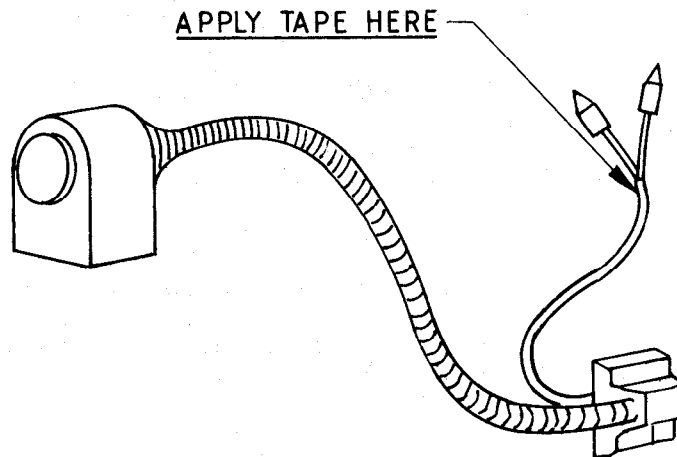
FIG 2 - MAPLIGHT WIRING

1. This instruction details the fitting of an improved maplight securing clip and the securing of the maplight wiring to prevent it short circuiting on the rear of the dashboard.

- c. Fit the new clip (item 1 from Table 1) using the original mounting screws and plug the existing hole with a screw (item 2 from Table 1).
- d. Ensure that a sleeve is fitted over the maplight wiring, see Fig 2, and that the sleeve is located in the hole in the dash.
- e. If the sleeve is located in the dash then apply insulation tape at the point shown in Fig 2.

- g. Remove the maplight securing screws and the maplight, and inspect the maplight wiring for chafing.
 - h. If chafing is evident repair the wiring and fit the sleeve (item 3 from Table 1) over and secure as shown in Fig 2.
 - i. Reconnect the maplight wiring and refit the maplight to the dash.
 - j. Reconnect the battery and test the operation of the maplight.
8. Modification Record Plate. Deface the numeral 11 on the modification plate located on the drivers seat base.
9. Recording. Enter the details of the modification in Part Three of the TGM 120, Record Book for Service Equipment, of the subject vehicles.
