TRUCK, LIGHTWEIGHT, MC2, LAND ROVER 110 4X4 - ALL TYPES WITH MANUAL STEERING BOX

REPAIR OF MANUAL STEERING BOX SECTOR SHAFT END FLOAT

MODIFICATION INSTRUCTION

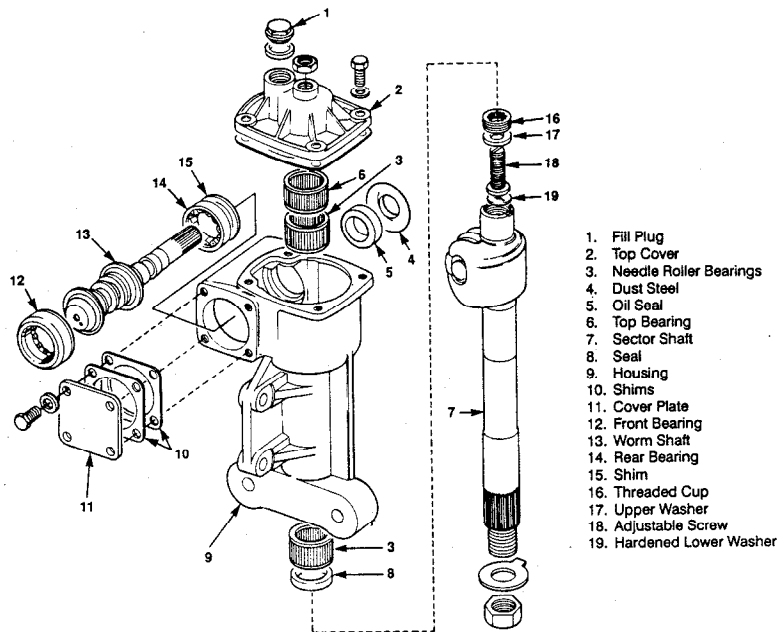
Figure 3 - Steering Box Exploded View

1. This instruction shows how to rectify excessive sector shaft end float in the Land Rover 110 4x4 manual steering box, and how to adjust backlash correctly. End float is caused by excessive clearance between the sector shaft adjuster and the securing plug. It causes vertical movement of the sector shaft when the steering wheel is turned.

- e. Fit the hardened washer, adjuster screw, upper washer and new securing plug (Item 2), as shown in Figure 3.
- f. Tighten the threaded plug using the inserting tool shown in Figure 1 until the adjusting screw is firmly clamped, then back off the plug until the adjusting screw is free to rotate.
