TRUCK, UTILITY, LIGHTWEIGHT, MC2 – LAND ROVER 110 4X4 – ALL TYPES

REPLACEMENT OF FRONT AXLE DIFFERENTIAL COVER PLATE

MISCELLANEOUS INSTRUCTION

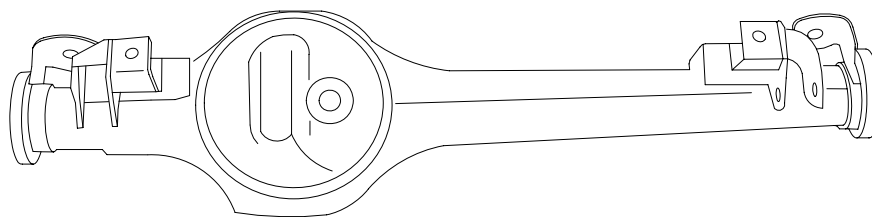
Figure 1 Correct Location of Cover Plate to Axle Housing

The long centre line of the crown wheel clearance hump is at right angles to the transverse centre line of the axle housing and the filler plug opening is on the same side as the long axle tube (Figure 1).

- d. After removal of the cover plate, all weld metal residue and dross is to be removed. Any indications in the axle housing are to be re-welded using the consumables listed in sub-para h. The repaired area is to be ground back to the original profile.
- e. Position the cover plate on the axle housing so that it is centrally located on the differential opening.

- f. Tack weld the cover plate in position using the consumables listed in sub-para h.
- g. Using a small hammer, tap the edge of the cover plate down onto the axle housing.
- h. Weld the cover plate to the axle housing with a 2 mm continuous fillet weld, ensuring that the top edge of the weld joint is fully consumed.
