TRUCK, AMBULANCE, LIGHT, 4 LITTER, FFR, WINCH, MC2-LAND ROVER 110 6X6

RELOCATION OF THE SEVEN PIN AUXILIARY PLUG AND HARNESS ASSEMBLY

MODIFICATION INSTRUCTION

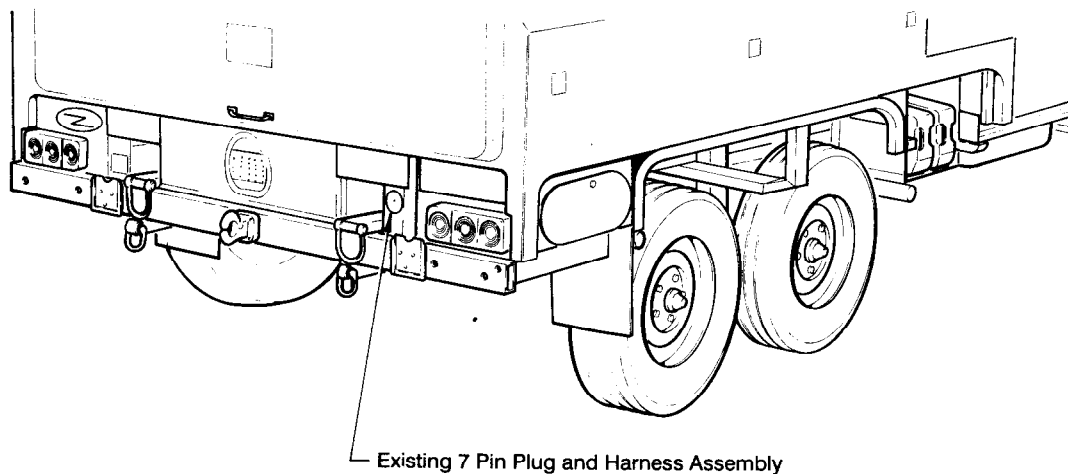
Figure 1 - Existing 7 Pin Auxiliary Plug Location

1. This instruction details the relocation of the seven pin auxiliary plug and harness assembly from the outside face to the inner side of the right rear chassis upright, to prevent damage to the wiring during off road operation. A new bracket has been introduced to mount the plug and harness. The relocation of the plug was carried out in production from Jul 90 and rework only affects early ambulance variants.

10. **Proceed as follows:**
  - a. Disconnect the vehicle battery.
  - b. Locate the existing 7 pin auxiliary plug on the right rear chassis upright, as shown in Figure 1.
  - c. Disconnect the plug cable from the chassis harness at the multi pin connector located on the rear chassis rail and the earth wire at the bullet connector.

- d. Remove the three mounting screws holding the 7 pin plug to the chassis and remove the plug and harness assembly from the rear post of the chassis (retain screws for remounting of the plug).
