TRUCK, AMBULANCE, LIGHT, 4 LITTER, FFR, WINCH,
MC2-LAND ROVER 110 6X6

FITTING OF A SUPPORT BRACKET TO THE AIR
CONDITIONER COMPRESSOR HOSES

MODIFICATION INSTRUCTION

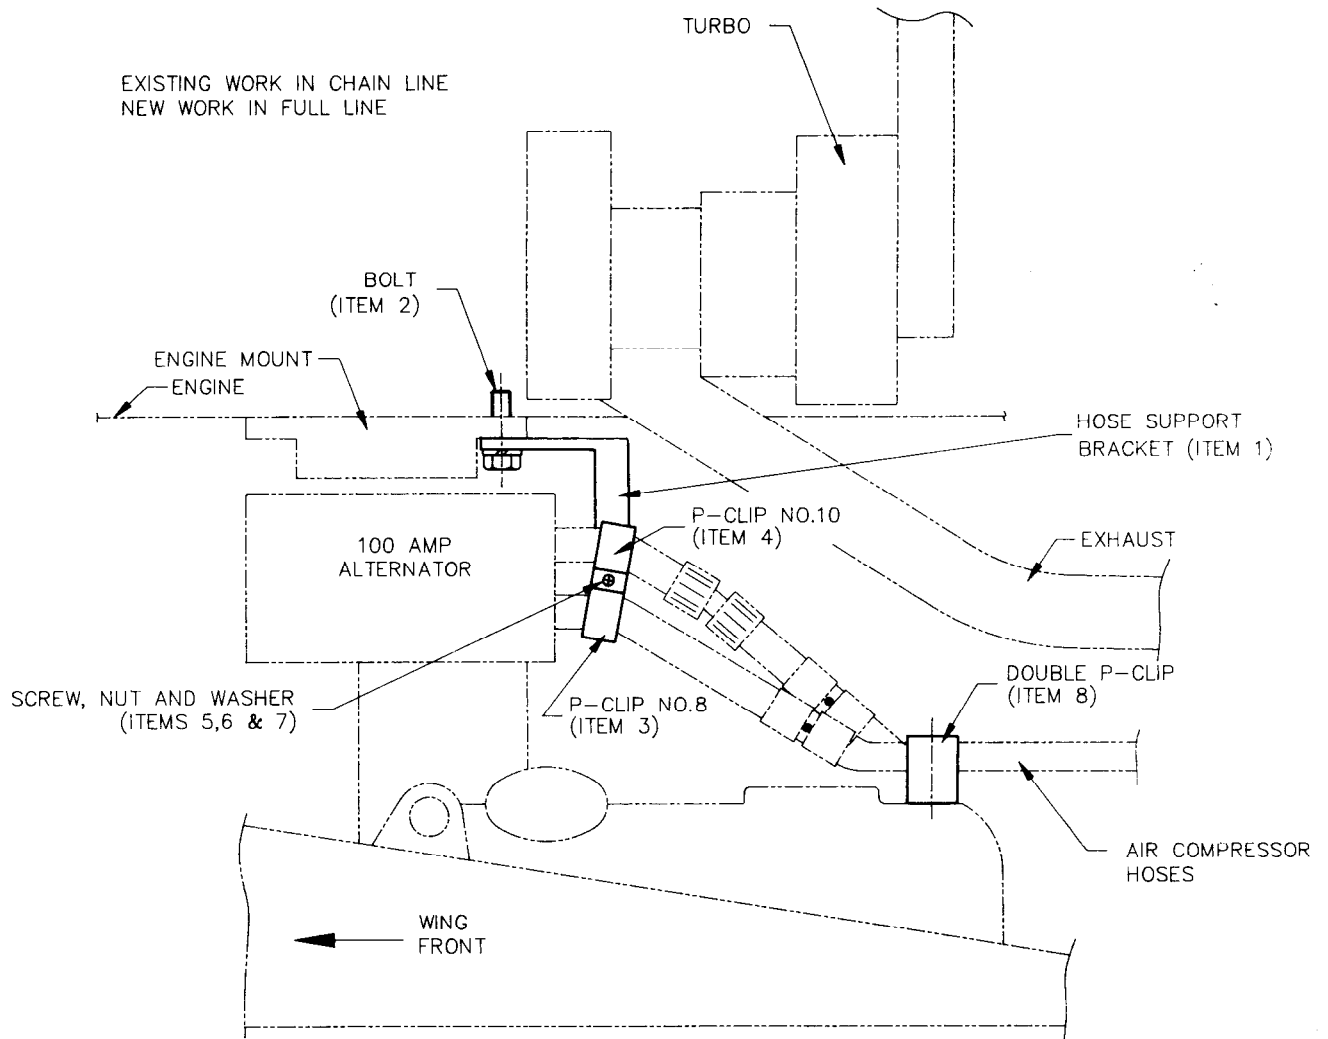
Figure 1 - Air Conditioner Hose Support Bracket

1. This instruction details the fitting of a support bracket to the air conditioner compressor hoses to reduce vibration and subsequent breakage of the hose unions. The instruction is to be read in conjunction with VEHICLE G 229-1, which details replacement of the current air conditioner hoses, on failure.

11. The modification is to be carried out as follows, with reference to Fig 1 for component location.

- Inspect the airconditioner hoses and replace damaged hoses as detailed in Vehicle G 229-1.
- Remove the two rearmost bolts from the LHS front engine and alternator mounting bracket.
- Fit the support bracket (item 1) to the engine mount using new longer mounting bolts (item 2)(the aircon hoses should be resting on top of the bracket at this stage).
- Fit the "P" clips (item 3 and 4) to the hoses and attach the clips to the support bracket using screws, nuts and washers (item 5,6,7).

e. Fit the double "P" clip (item 8) around the aircon hoses adjacent to the exhaust pipe and fit to existing bolt.
