TRUCK, ELECTRONIC, LIGHT, MC2, - LAND ROVER 110 6X6
ELECTRONIC REPAIR VEHICLE (ERV)

MODIFICATIONS TO THE MODULE AIR-CONDITIONING SYSTEM

MODIFICATION INSTRUCTION

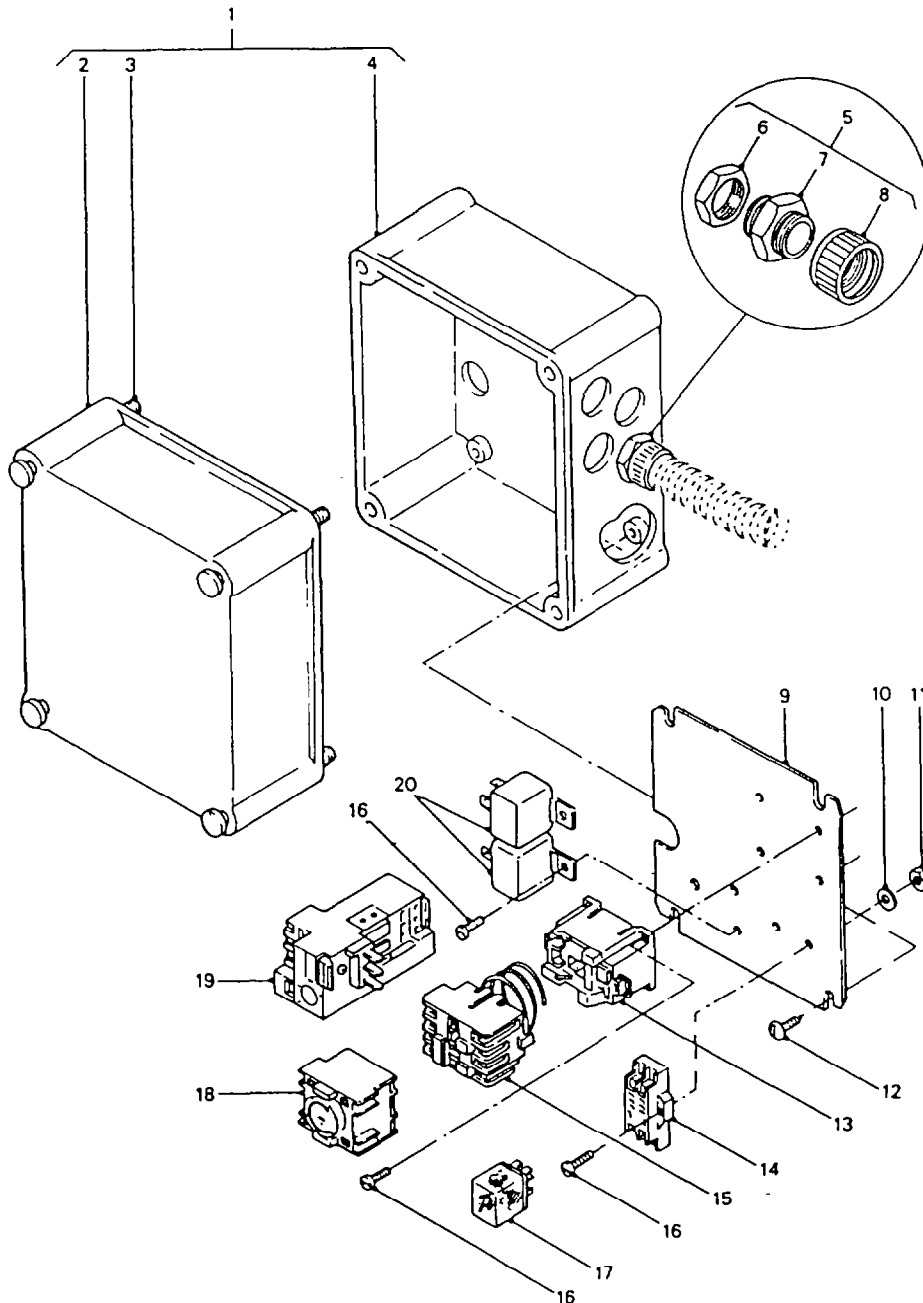
Figure 7 - Air-Conditioner and Thermostat Switch Relay Box

23. All applicable vehicles shown in Table 1 are to have the contactor (Item 3, Table 3) replaced by Army tradesmen. The contactor is being replaced due to constant problems with burnout. The failures are associated with the output limit of the 15 KVA generator when it is subjected to an instantaneous 240 volt motor start up load and corresponding voltage drop at the contactor coil. Proceed as follows:

- d. Identify the power box (Figure 7, Item 1) and remove the cover, then slide out the power divider plate.
- e. Slide the timer (Figure 7, Item 18) off the contactor by depressing the locking tongue at the front face.

- f. Unscrew overload mechanism from C1 contacts and retain (Figure 7, Item 19).
- g. Remove the four big headed screws holding the relay mounting plate in the back of the power box and slide out to provide access to the contactor base retaining screws nuts.

- h. Disconnect all wires and fixing screws from 'C1' contactor and remove from the control box (Figure 7, Item 15, 13).
- i. Install new contactor 'C1' with 24 volt DC coil.

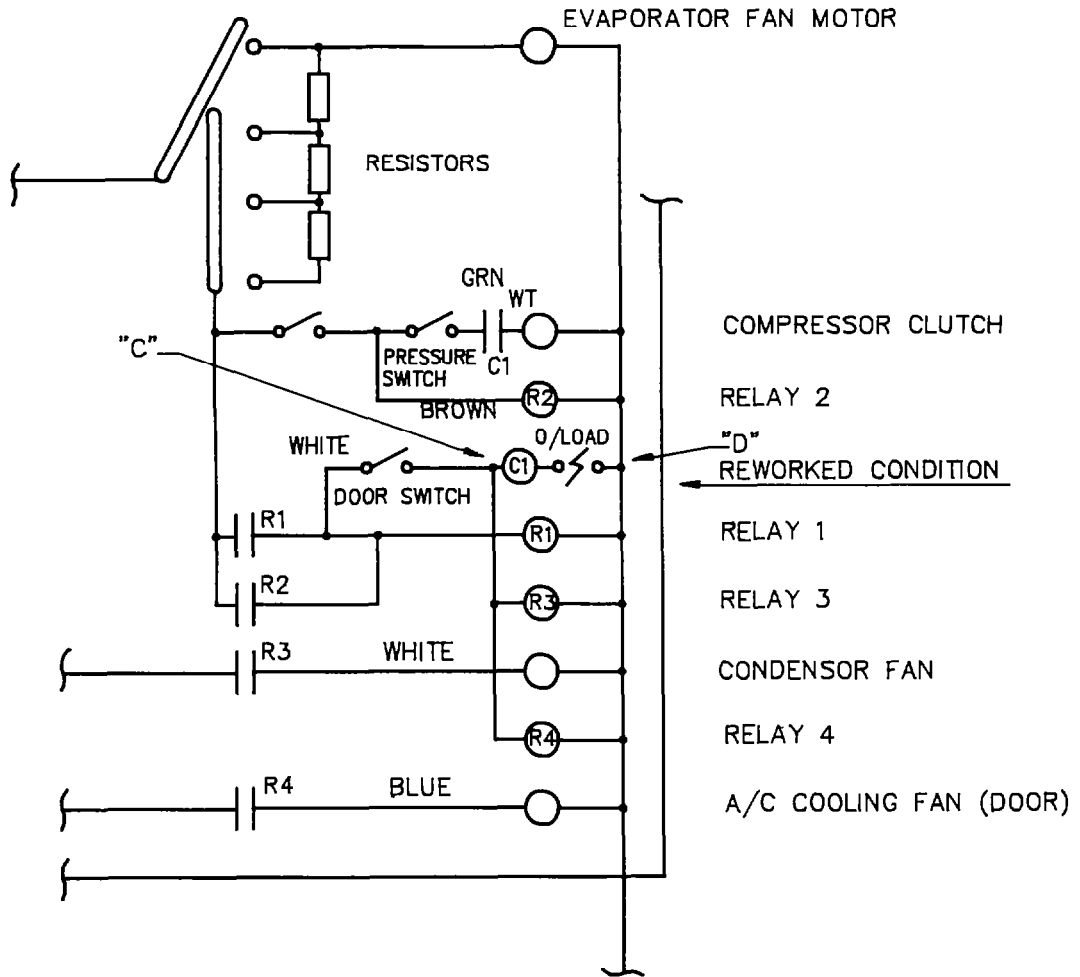
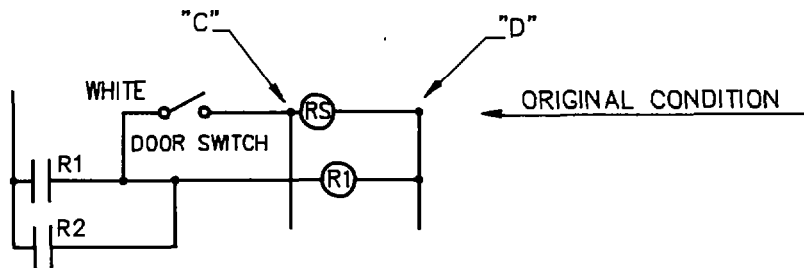
Figure 9 - Revised Wiring (Door Switch)

NOTE: CIRCUIT "C" AND "D" REVISED FROM 'ORIGINAL' CONDITION TO 'REWORKED' CONDITION.

Revisions to the circuits are shown in Figures 9 and 10. A revised circuit diagram for EMEI Vehicle G 253 will be issued separately.
