TRUCK, CARGO, LIGHT, MC2, LAND ROVER 110 6X6 - ALL TYPES

REPLACEMENT OF THE LOWER THROTTLE LINKAGE LEVER

MODIFICATION INSTRUCTION

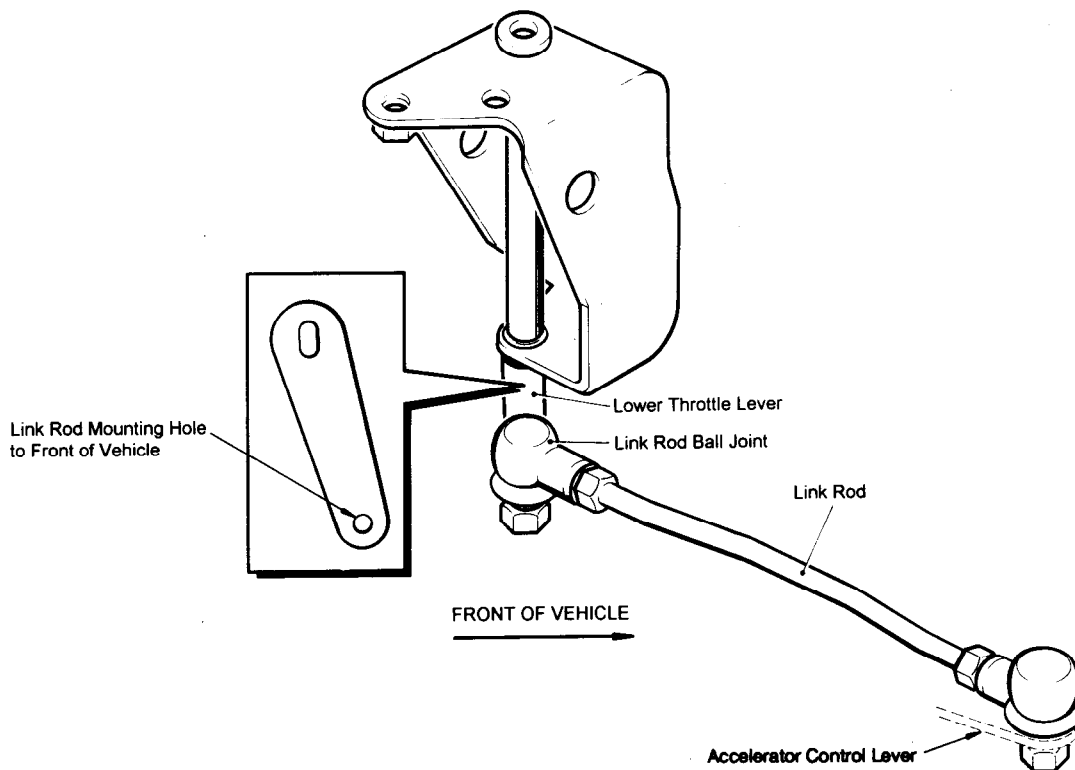
Figure 1 - Throttle Linkages

1. This instruction details the replacement of the existing lower throttle linkage lever with a modified lever and adjustments to the fuel injection pump, to allow full throttle travel. The replacement is due to an Engineering Change by Land Rover Australia and is necessary to ensure full power is obtained whilst driving.

- a. Ensure that the engine is at operating temperature.
- b. Replace the lower throttle lever, see Figure 1, with the new lever (item 1 from Table 2), ensuring that the link rod mounting hole is toward the front of the engine.
- c. Leave the link rod ball joint disconnected from the throttle lever and, if necessary,

It may be necessary on some vehicles to remove and trim the link rod (see Figure 1) by 5 mm to allow full adjustment of the linkages.
