TRUCK, AMBULANCE, LIGHT, 4 LITTER, FFR, WINCH, MC2 - LAND ROVER 110 6 x 6
TRUCK, ELECTRONIC REPAIR, LIGHT, MC2 - LAND ROVER 110 6 x 6
TRUCK GENERAL MAINTENANCE, LIGHT, WINCH, MC2 - LAND ROVER 110 6 x 6

FITMENT OF A HEAVY DUTY INDICATOR FLASHER UNIT

MODIFICATION INSTRUCTION

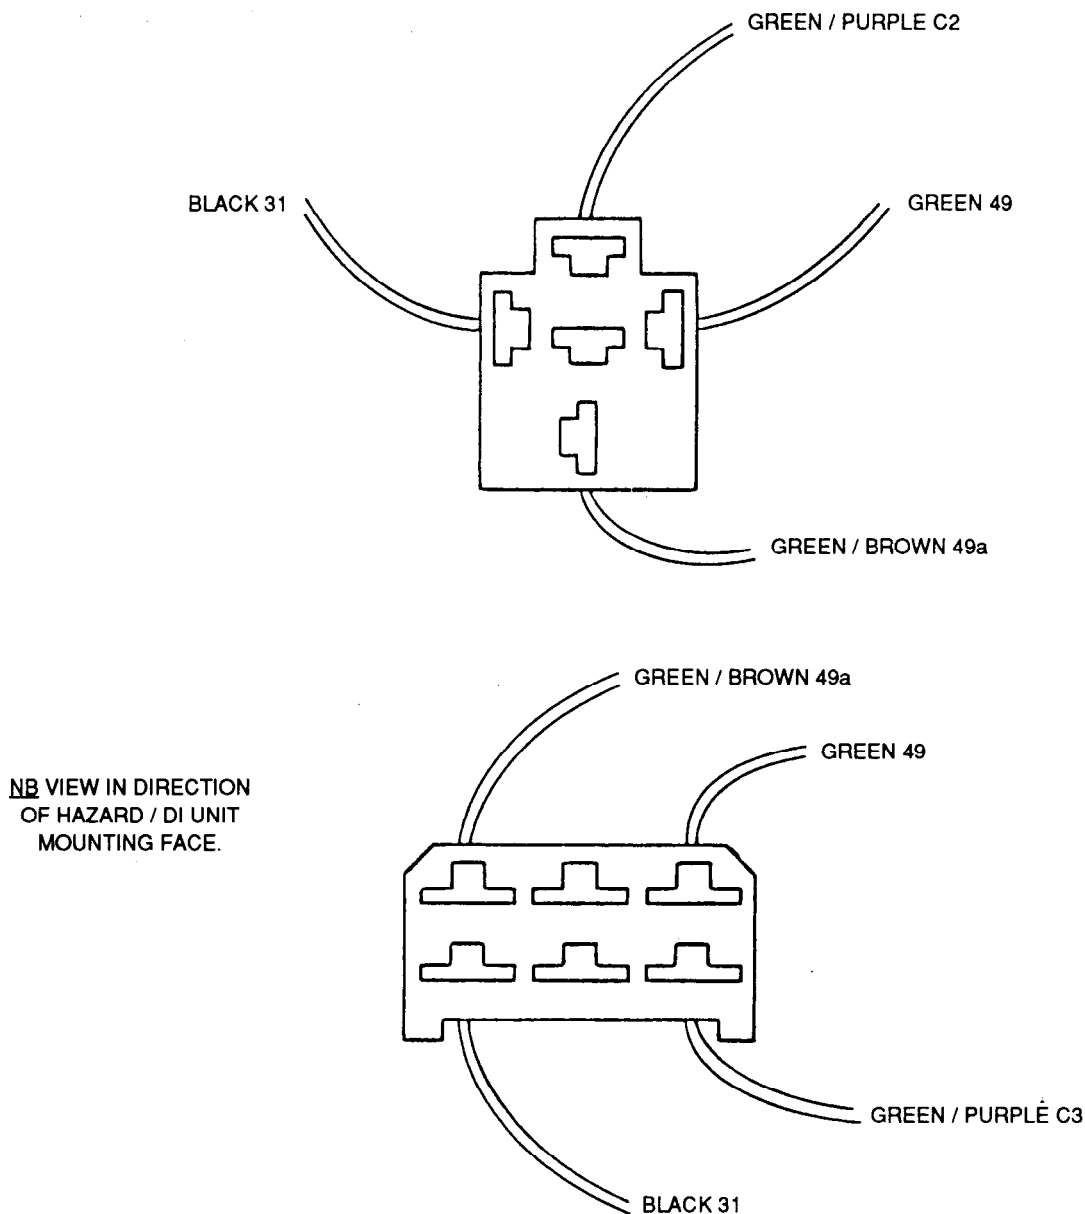
FIG 1 - INDICATOR FLASHER UNIT CONNECTOR WIRING

1. This instruction details the replacement of the indicator flasher unit on variants fitted with module to enable correct functioning of the dash mounted trailer warning lamp.

1. Ensure the wires are refitted correctly or wire burn out will occur.

7. The modification is to be carried out as follows:
 - a. Disconnect the vehicle battery.
 - b. Remove the fuse panel cover.
 - c. Remove the two screws securing the fuse box mounting plate to the bulkhead and pull the plate gently outwards to provide access to the indicator flasher unit.
 - d. Remove the flasher unit securing screw and disconnect the wiring connector plug.
 - e. Remove the four terminals from the connector plug by carefully inserting a narrow blade screwdriver into each connector aperture to release the lock tab.
 - f. Refit the terminals to the new connector plug (item 1 from Table 2) as shown in Fig 1.

- g. Connect the plug to the new flasher unit (item 2 from Table 2).
- h. Refit the flasher unit to the fuse panel.
- i. Refit the fuse panel mounting plate to the bulkhead and secure the fuse panel cover.
- j. Reconnect the battery and check the flasher unit operation.
8. Modification Record Plate. Deface the numeral 11 on the modification plate located on the drivers seat base including the vehicles modified in production.
9. Recording. Enter the details of the modification in Part 3 of the TGM 120, Record Book for Service Equipment, for the subject vehicles, including the vehicles modified in production.
