**TRUCK, LIGHTWEIGHT AND TRUCK, LIGHT – ALL TYPES
LAND ROVER 110 4X4 AND 6X6****CONFIGURATION, INSPECTION, MAINTENANCE AND REPAIR OF PROP SHAFTS****GENERAL INSTRUCTION**

2. The purpose of this instruction is to provide configuration, inspection, maintenance and repair level guidelines for Land Rover 110 FOV prop shaft assemblies.

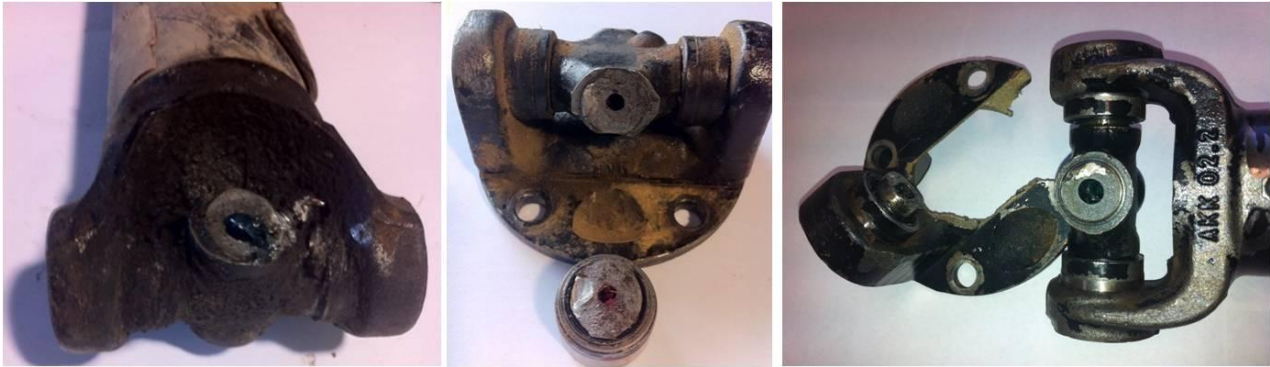
Figure 1 Fractured Universal Joint Examples

9. Main failure modes reported by RODUM consist of the following (Figures 1, 2 and 3):
- universal Joints fracturing,
 - sliding female spline yoke ears fracturing,
 - prop shaft separation from the sliding yoke, and
 - flanges fracturing.

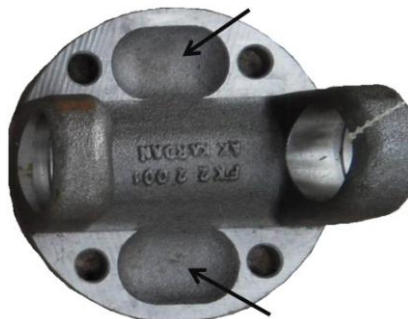
Figure 4 Scalloped Flange

12. Land Rover specifications for the flanges ensure that strength and life hour are maintained within the complete prop shaft assembly. Design features include the following:
- The flange face has 360° of material on the mounting face with a diameter of approximately 97mm.

- b.** The flange is made of a forged steel and not cast iron. (cast iron flanges were prone to failure with early testing).
- c.** The flange thickness is $7 \text{ mm} \pm 0.5 \text{ mm}$. (this measurement is critical for strength and to ensure there is full thread contact with the 4 x locating nuts).
- d.** The flange is scalloped to provide for 20° of angle movement (Figure 4).

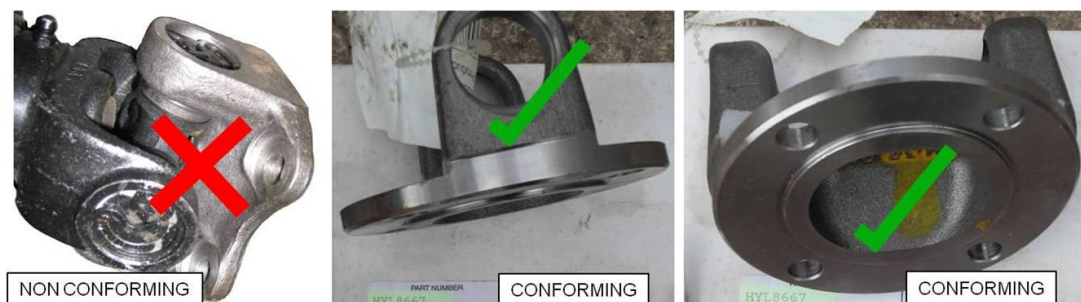
Figure 5 Cast Flange (Non-Conforming) and Forged Steel Flange (Conforming)

13. Flange Comparisons. Figures 5 and 6 detail comparisons between conforming and non-conforming flanges.

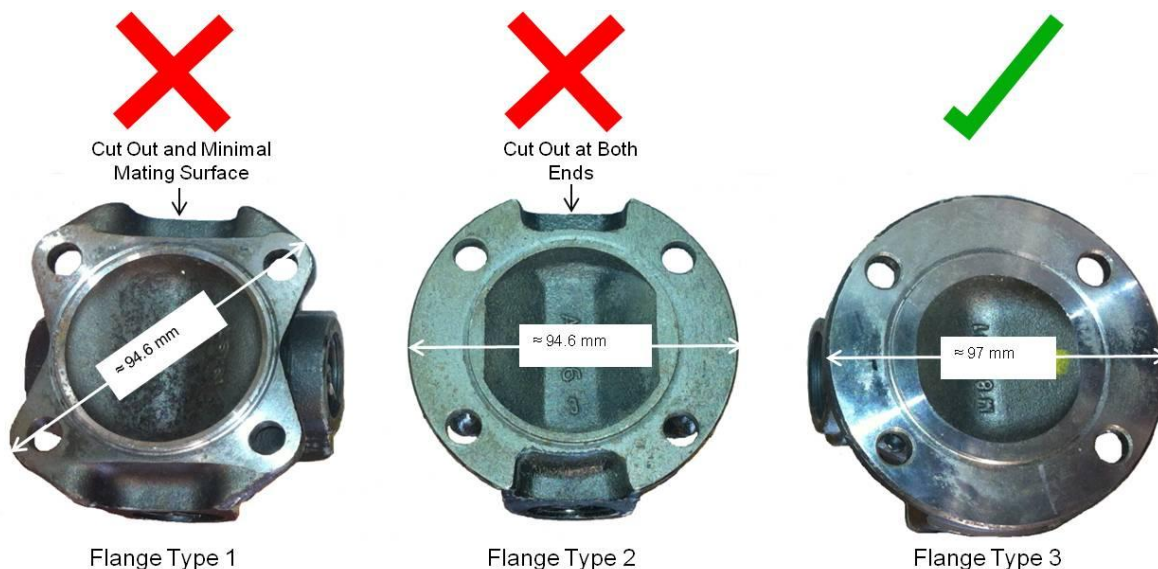
Figure 6 Prop Shaft Flange Comparisons

Serial	Flange Type	Material	Thickness	Diameter	360° Full Mating Surface	Conforms to Design Specification
1	Type 1	Cast Iron	4.4 – 7.4 mm	≈ 94.6 mm	No	NO
2	Type 2	Cast Iron	5.9 mm	≈ 94.6 mm	No	NO
3	Type 3	Forged Steel	$7 \text{ mm} \pm 0.5$	≈ 97 mm	Yes	YES

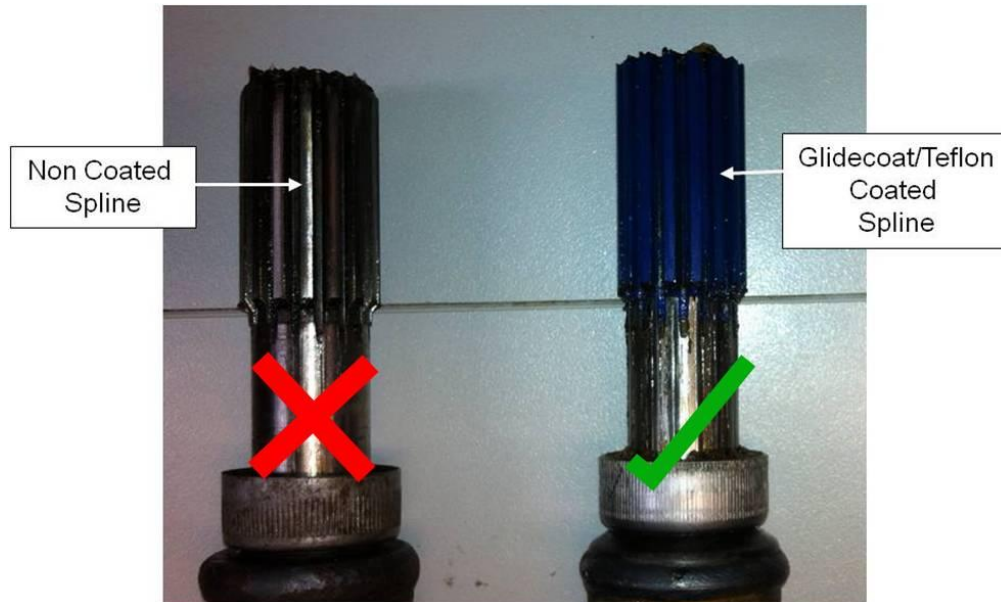
Figure 7 Spline Plug Comparison

- a. The sliding female spline is made of forged steel or heavy duty cast iron. This maximises strength while still providing for the 20° working angle.
- b. The spline plug is coated with either Glidecoat™ or Teflon™ for durability and smooth movement (Figure 7).

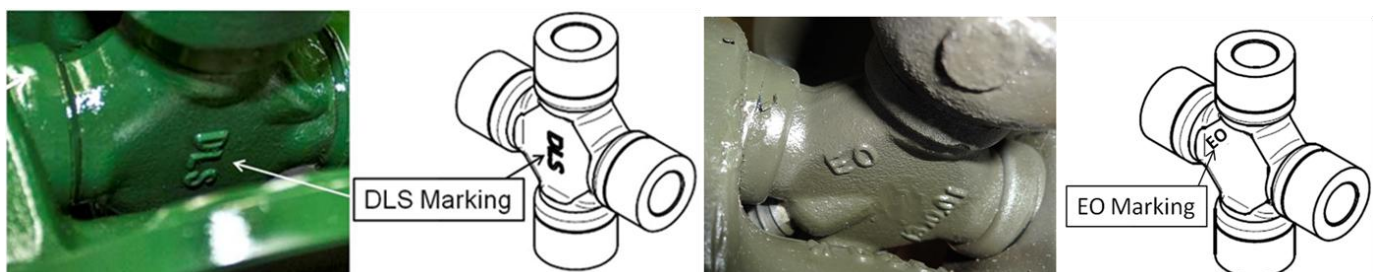
Figure 8 DLS and EO Universal Joints

- a. All genuine LRA prop shaft assemblies are specified with a DLS or EO heavy duty universal joints (Figure 8). Genuine LRA replacement universal joints (GKN) and packaging are shown at Figure 9. Features of both types of universal joints include:
 - (1) Thrust pad between the cross and bearing cap (the thrust pad ensures against cross float and maintains bearing load).
 - (2) A large bearing journal and a triple lip seal to minimise lubrication contamination.

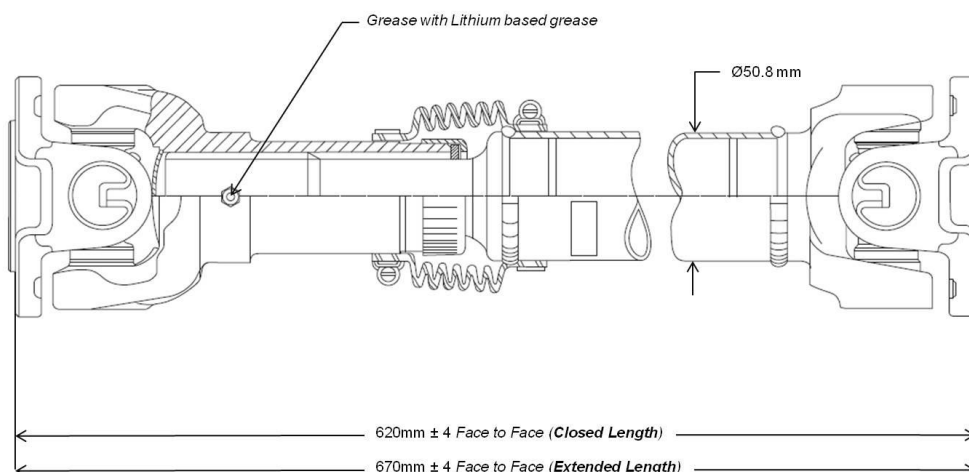
Figure 10 Front Prop Shaft – NIIN 66-128-4256 / LRA PNo: AYG4281

19. Figure 10 details 4x4 and 6x6 front prop shaft length measurements.

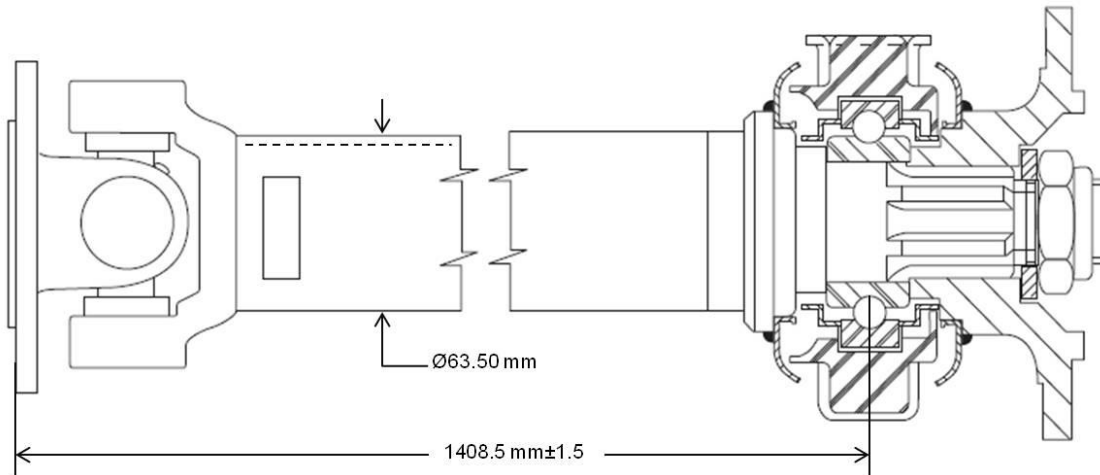
Figure 11 6x6 Shaft W-Centre Bearing – NIIN 66-128-5663 / LRA PNo: AYG7333

Critical measurement is from the transmission flange to centre of centre bearing
(1408.5mm \pm 0.5).

20. Figure 11 details the 6x6 centre bearing prop shaft length measurements.

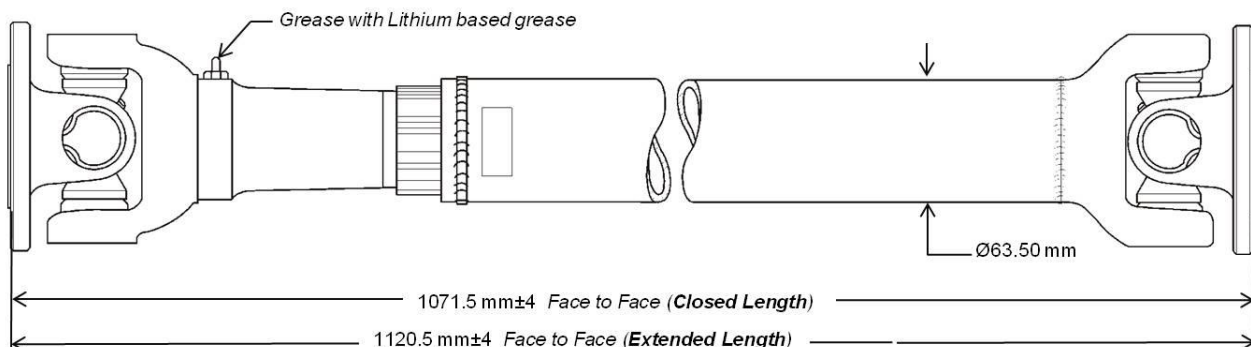
Figure 12 4x4 Rear Prop Shaft – NIIN 66-128-4249 / LRA PNo: AYG7332

21. Figure 12 details the 4x4 rear prop shaft length measurements.

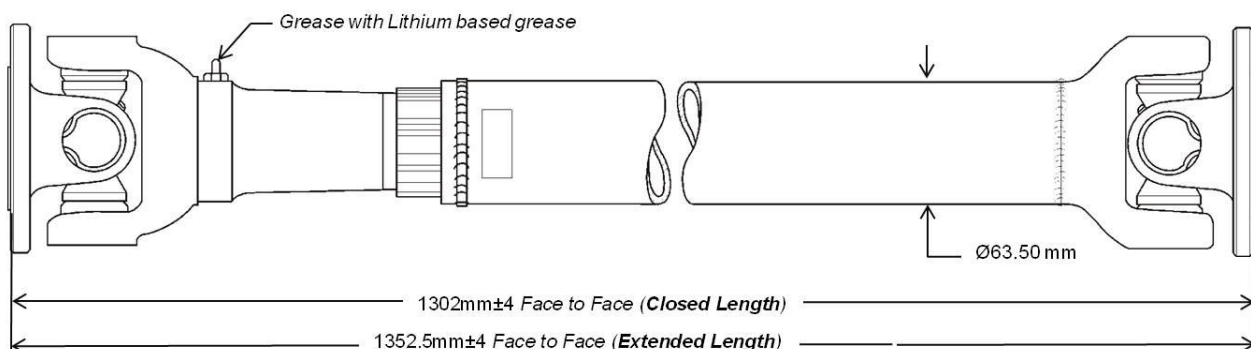
Figure 13 6x6 Gearbox to Intermediate Axle Prop Shaft – NIIN 66-128-5662 / LRA PNo: AYG7331

22. Figure 13 details the 6x6 gearbox to intermediate axle prop shaft length measurements.

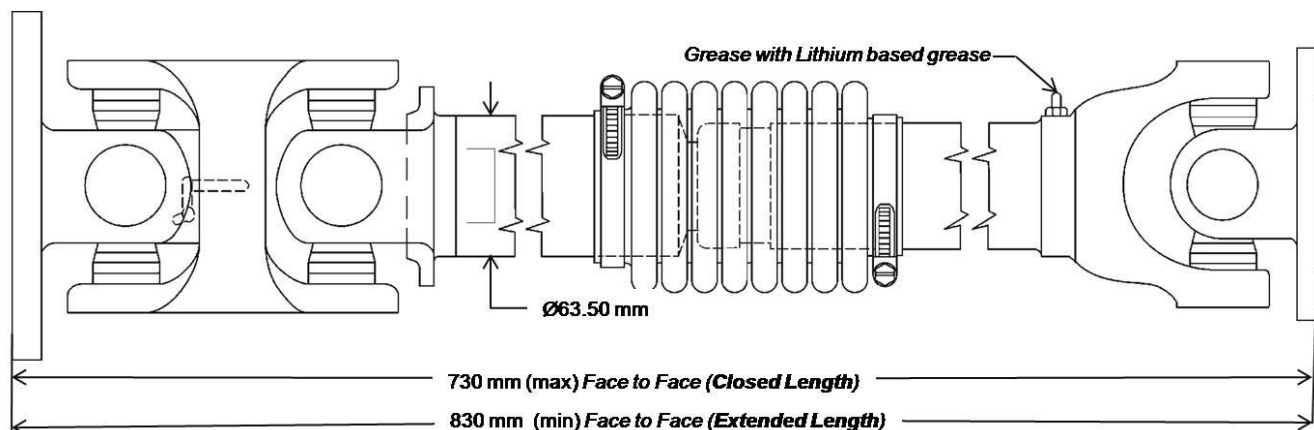
Figure 14 6x6 Centre Bearing to Rear Axle Prop Shaft – NIIN 66-128-5667 / LRA PNo: AYG7202

23. Figure 14 details the 6x6 centre bearing to rear axle prop shaft length measurements.

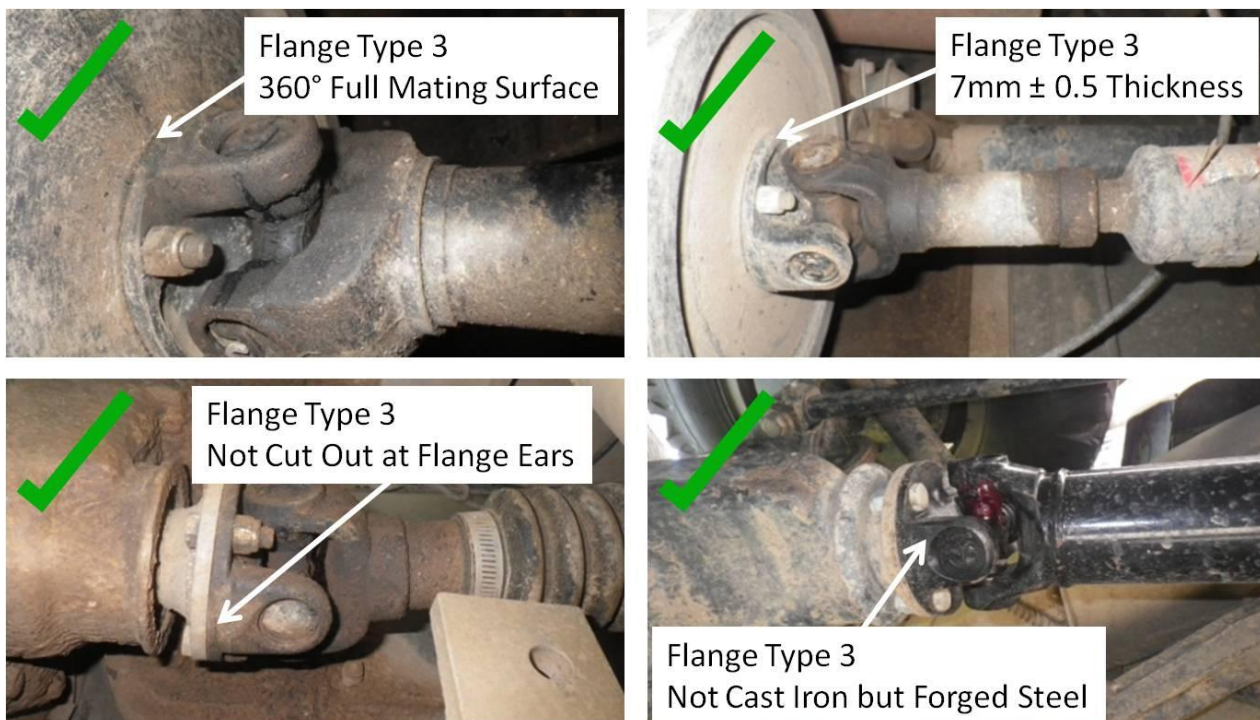
- (1) **Correct Flanges Fitted** (Figure 15). Vehicle prop shaft assembly configuration is serviceable.

Figure 15 Correct Flanges Fitted (For flange identification details, refer to Figure 5)

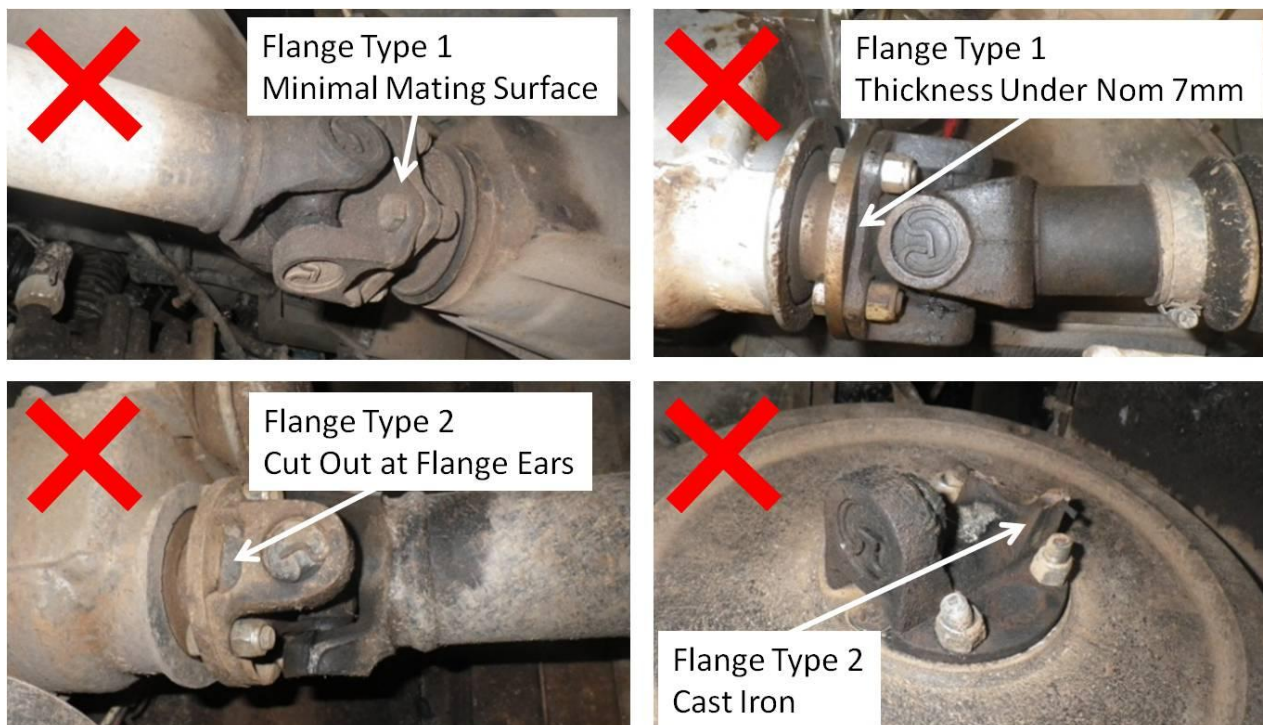
- (2) **Incorrect Flanges Fitted** (Figure 16): Go to stage 2.

Figure 16 Incorrect Flanges Fitted (for flange identification details, refer to Figures 4, 5 and 6)

- b. Stage 2.** Remove non conforming prop shaft assembly from the vehicle.

- (1)** Inspect prop shaft length as detailed at Paras 19 through to 23.
- (a)** *Correct Length* (within Tolerances).
- i.** Replace incorrect flange/s and universal joint/s IAW vehicle variant Light Grade Repair EMEI.
 - ii.** Refit conforming prop shaft assembly to vehicle.
- (b)** *Incorrect Length* (Outside Tolerances). Dispose of IAW current disposal instructions.

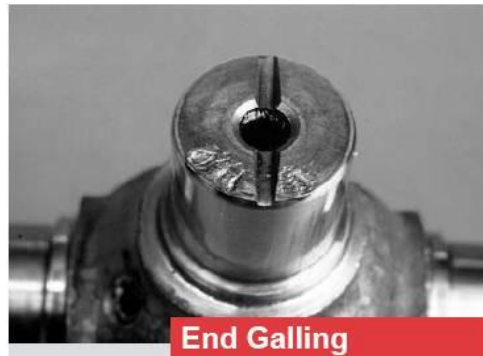
Figure 17 End Galling

- 27.** Probable causes for end galling include (Figure 17):
- a.** excessive universal joint operating angles;

- b. improper assembly procedures;
- c. sprung or bent yoke; and
- d. lack of lubrication (improper maintenance).

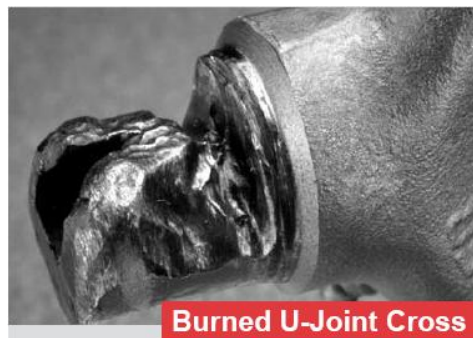
Figure 18 Burned Universal Joint Cross

28. Probable causes for a burned universal joint cross include (Figure 18):
- a. lack of lubrication (improper maintenance);
 - b. wrong lubrication type; and
 - c. improper application.

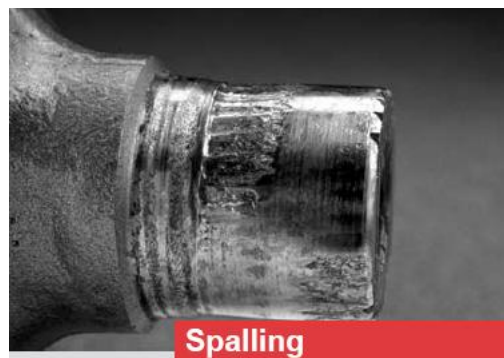
Figure 19 Spalling

29. Probable causes for spalling include (Figure 19):
- a. water contamination,
 - b. wrong lubrication type, and
 - c. lubrication failure.

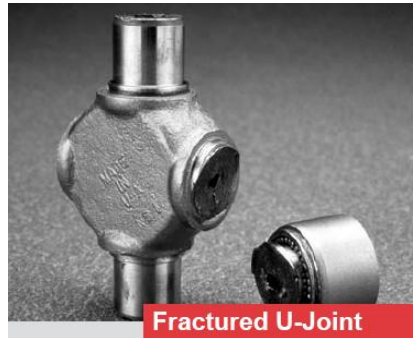
Figure 20 Fractured U-Joint

- 30.** Probable causes for a fractured universal joint include (Figure 20):
- a.** excessive torque loads,
 - b.** shock loads, and
 - c.** improper application.

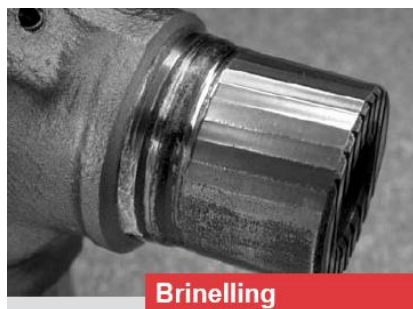
Figure 21 Brinelling

- 31.** Probable causes for brinelling include (Figure 21):
- a.** continuous excessive torque loads,
 - b.** seized slip yoke splines, and
 - c.** excessive driveline angles.

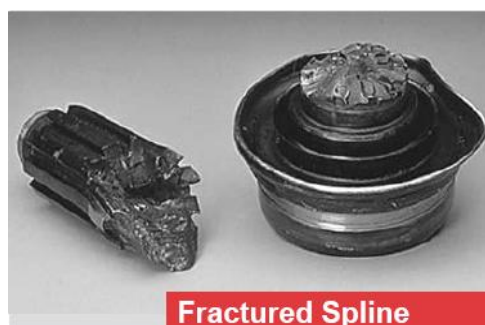
Figure 22 Fractured Spline

- 32.** Probable causes for a fractured spline are (Figure 22):
- a.** excessive torque loads,
 - b.** shock loads, and
 - c.** improper application.
