This Guide provides information about identifying, managing and handling low density asbestos fibre board (LDB) in workplaces.

## What is low density asbestos fibre board?

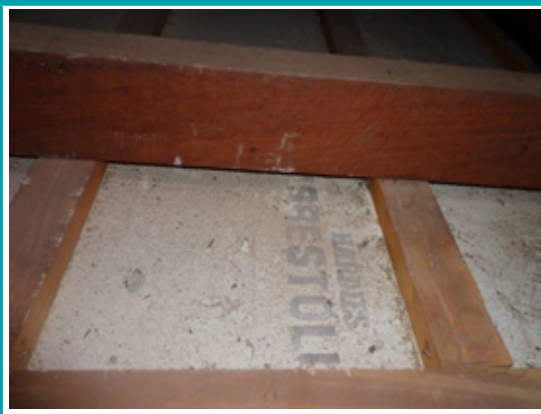
**Figure 1** Rear side of LDB ceiling sheet showing trade name

**Label:** LDB can be identified by looking at the rear side of the sheeting for the trade name Asbestolux or Duralux, as shown in Figure 1. The absence of a label does not mean the material is asbestos free.

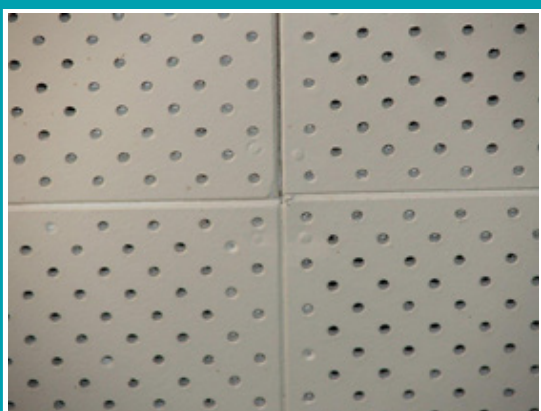
**Figure 2** Front side of perforated LDB

**Ceiling sheets/tiles:** LDB was often used as ceiling tiles/sheets and for acoustic purposes. LDB ceiling tiles were commonly perforated. Different patterns of perforated ceiling tiles were used with the difference being the number of holes per sheet as shown in Figure 2.

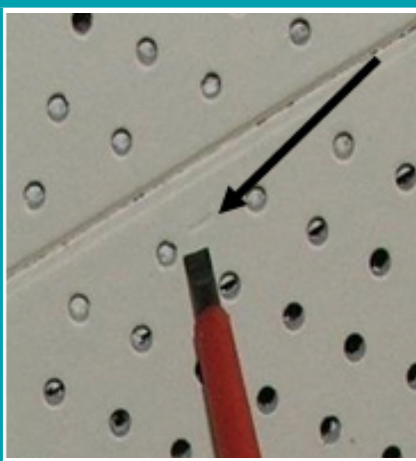
**Figure 3** Hand pressure from a screwdriver will dent the surface

**Hardness:** LDB is softer than asbestos cement sheeting because calcium silicate plaster was used to bond the asbestos fibres instead of cement. When tapped, for example with a car key, LDB will produce a dead or dull sound, indicating a soft or low density product. Using hand pressure, the head of a screwdriver will easily dent the surface as shown in Figure 3.

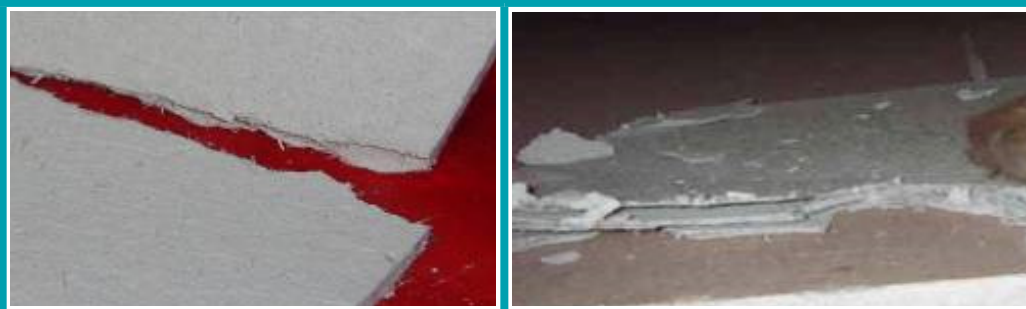
**Figure 4** Ragged or torn edges of broken LDB

When broken the edges of LDB appear ragged or torn with no sharp edges as shown in Figure 4. You can see a high percentage of asbestos fibres—the entire surface of the broken sheeting looks furry or fibrous.

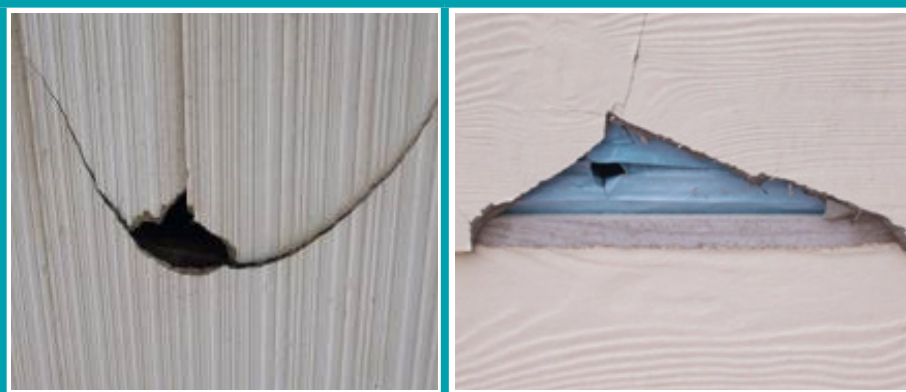
**Figure 5** Examples of sharply broken edges on asbestos cement sheeting

Asbestos cement sheeting breaks more cleanly as shown in Figure 5.

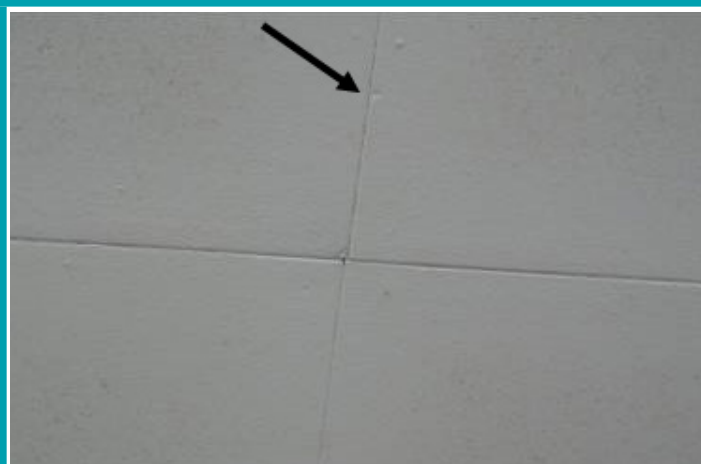
**Figure 6** Recessed fastener heads in LDB

**Finding fasteners:** The heads of fasteners, nails and clouts are often embedded or partially embedded or recessed into the surface of LDB sheeting due to the softness of the sheeting as seen in Figure 6.

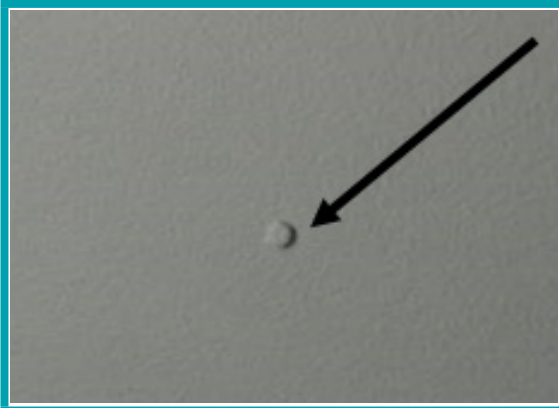
**Figure 7** Fastener in asbestos cement sheeting does not sit level with the surface

In contrast, the heads of the fasteners in asbestos cement sheeting do not sit level with the surface as seen in Figure 7.

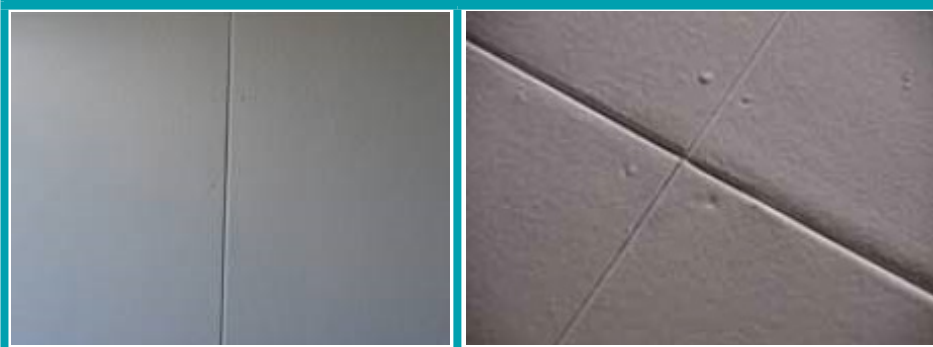
**Figure 8** Examples where fasteners are fixed into the LDB sheeting and the edges are bevelled or slanted

**Joins between sheets:** The edges of LDB products were often bevelled or slanted and hand planed so when fixed together with another sheet, a V-joint finish would be produced as shown in Figure 8.

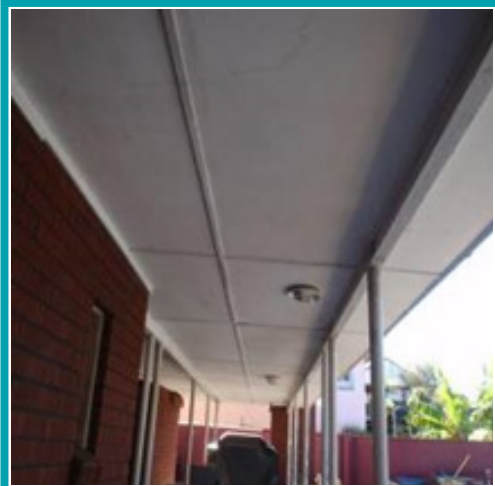
**Figure 9** Asbestos cement sheets joined with timber cover strips

Joins of asbestos cement sheeting are usually covered over with flat or moulded timber cover strips. The sheets are sometimes joined with timber cover strips as shown in Figure 9.
