# TRUCK, HEAVY, MC3 - MACK - ALL TYPES

#### REPLACEMENT OF WHEEL STUDS AND NUTS

# MODIFICATION INSTRUCTION

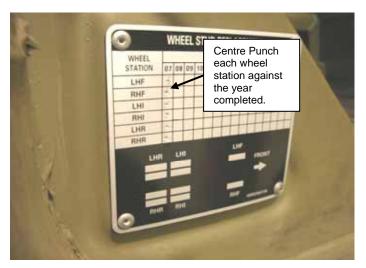
Figure 1 Wheel Stud Placard

- **18.** On completion of the wheel stud and nut replacement, the placard is to be centre-punched adjacent to the year completed, refer Figure 1, and the following action carried out:
  - **a.** Wheel Stud Placard. The wheel stud placard is to be riveted to the vehicle in the following locations:

**19. Future Wheel Stud Changes.** The wheel stud placard is to be struck whenever all studs have been replaced on a particular wheel station on a new calender year, refer Figure 1. This could be as a result of axle assembly, wheel hub assembly or when all studs on a particular hub assembly have been changed. The placard is to be struck adjacent to the respective wheel station that has had all studs replaced. This EMEI will remain a source document for future wheel stud replacement on the subject fleet after the initial replacement of the wheel studs and nuts is performed.
