TRUCK, UTILITY, LIGHTWEIGHT, MC 2 - LAND ROVER 110  
TRUCK, UTILITY, LIGHTWEIGHT, WINCH, MC 2 - LAND ROVER 110

ROLL OVER PROTECTION AND  
FITTING OF HEAD RESTRAINTS

MODIFICATION INSTRUCTION

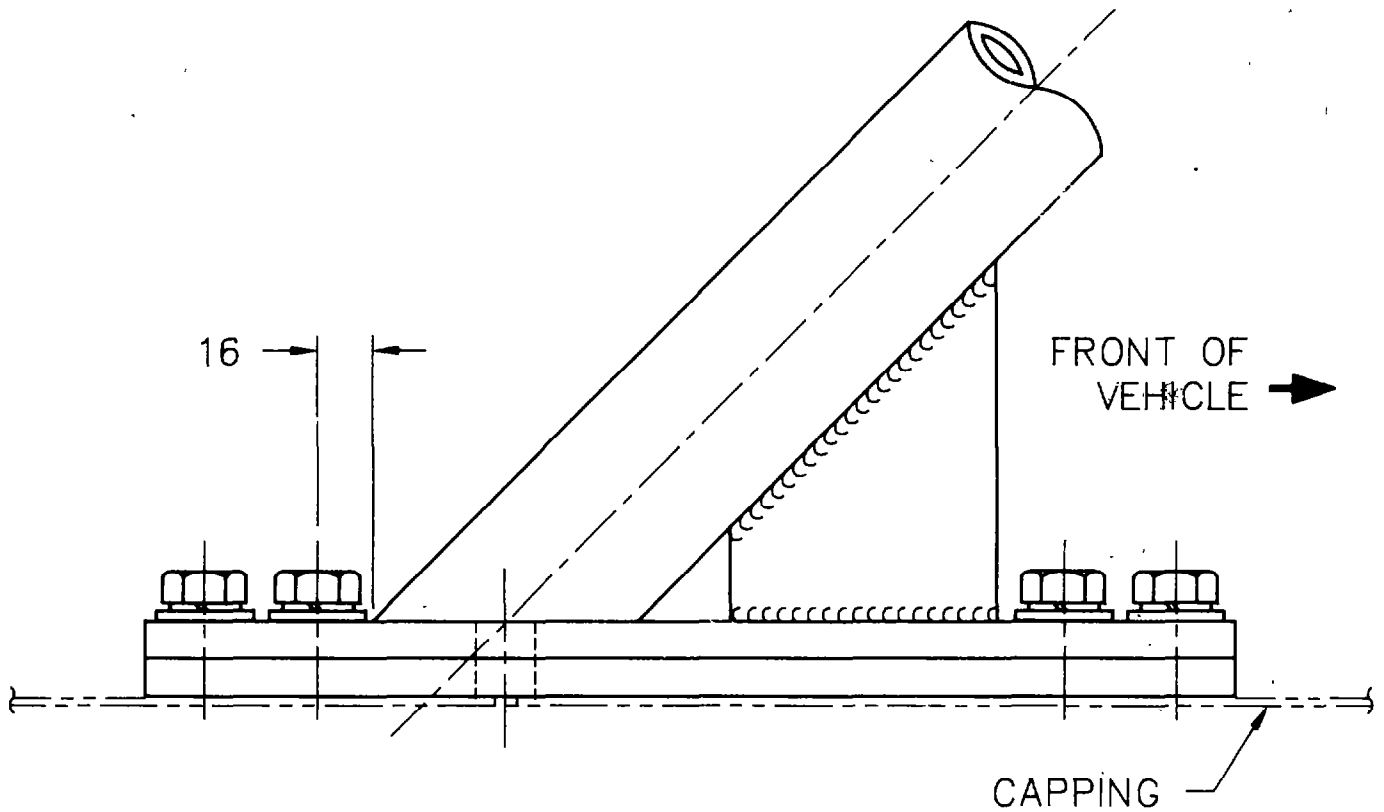
FIG 1 - POSITION OF CAPPING PLATES, REAR BRACE AND GUSSET

DIMENSIONS ARE IN mm  
NEW WORK IN FULL LINE  
EXISTING WORK IN CHAIN LINE

- j. Bolt capping plates (item 1e and 1f from Table 1) together to ensure correct alignment and maximum thread engagement is achieved.
- k. Position capping plates and rear braces (item 1a and 1b from Table 1) to obtain a flush fitting of rear braces to existing roll tube and upper capping plate ensuring a 16 mm clearance from pipe end to bolt centre as shown in Fig 1 is achieved.

- m. Position bolted plates and rear brace and tack weld lower plate to capping ensuring plate is in line with Top of Radius bend as shown in Fig 3 and the 16 mm clearance from pipe end to bolt centre as shown in Fig 1 is achieved.

- n. Tack weld rear braces to upper plates and existing roll tube.
- o. Position gusset (item 1g from Table 1) centrally to both rear brace and upper plate, ensuring that the bolts can be accessed with a ring spanner and tack weld into position, as shown in Fig 1.

- r. Mark and weld lower plate to capping as shown in Fig 2.
- s. Fully weld rear brace to upper capping plate and existing roll tube.
- t. Fully weld gusset as shown in Fig 1.

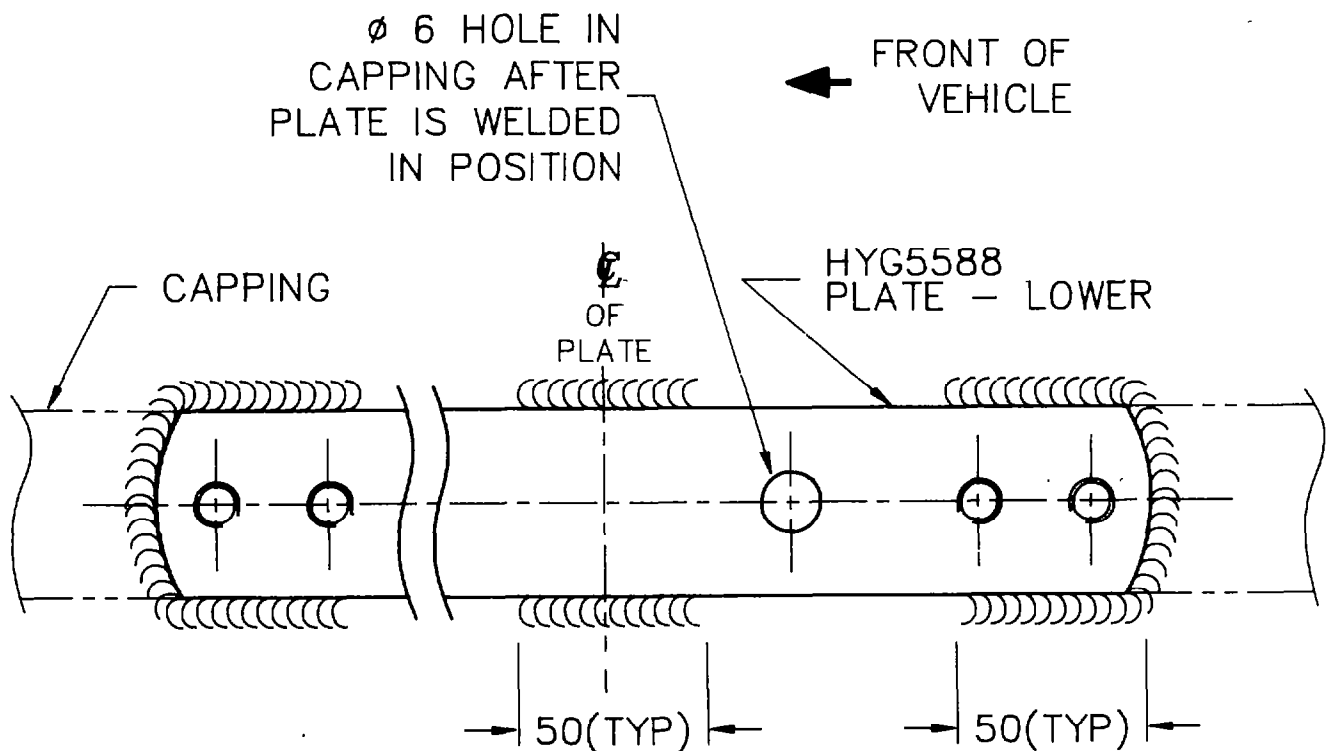
FIG 2 - WELD DIMENSIONS LOWER PLATE TO CAPPING

DIMENSIONS ARE IN mm  
NEW WORK IN FULL LINE  
EXISTING WORK IN CHAIN LINE

- aa. Drill a 6 mm hole in each capping rail as detailed in Fig 2.
- ab. Lower roll tube assembly and replace all mounting bolts, capping plate bolts are to be secured with Loctite 277.
- ac. Clean all welds and paint all exposed surfaces with primer, zinc rich epoxy and allow to dry, then apply olive drab (item 4 from Table 1) as a finish coat.

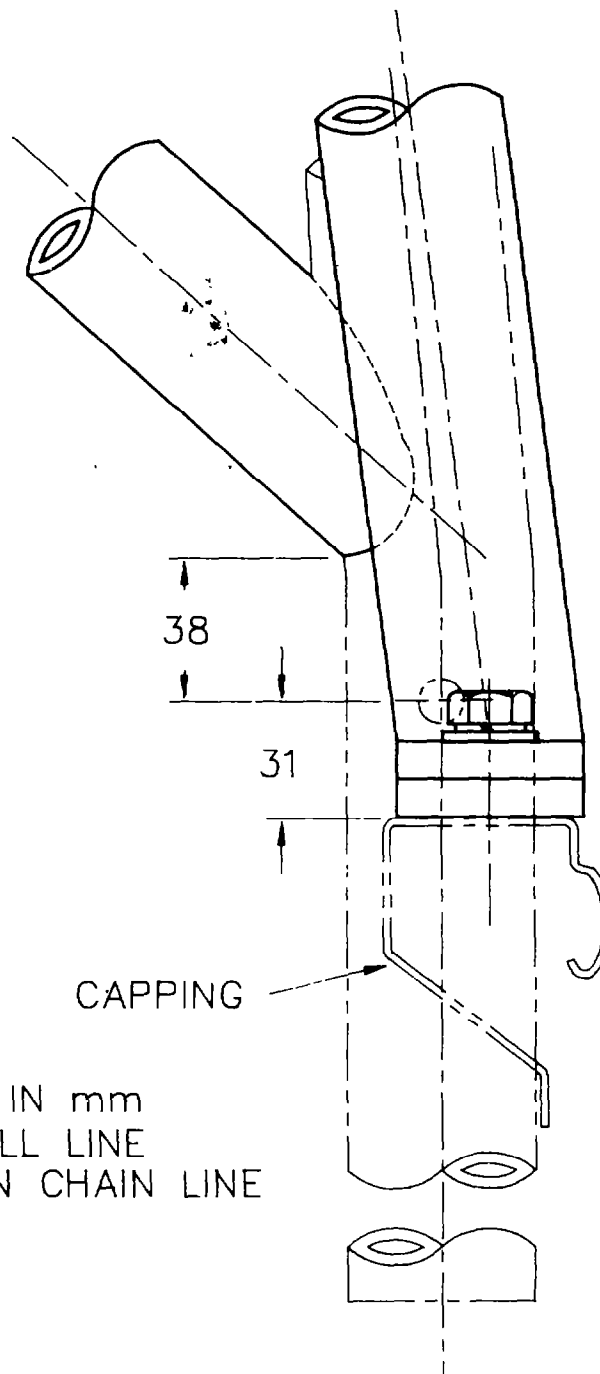
FIG 3 - POSITION OF CROSS BRACE

DIMENSIONS ARE IN mm  
NEW WORK IN FULL LINE  
EXISTING WORK IN CHAIN LINE

- p. Position corner braces (item 1d from Table 1) with lower edge 38 mm from existing bolt hole as shown in Fig 3, mark all contact areas and grind area free of galvanising to facilitate welding.
