## TRUCK, LIGHTWEIGHT AND TRUCK LIGHT – ALL TYPES – LAND ROVER 110 4X4 AND 6X6

### POWER ASSISTED STEERING BOX – REPAIR AND WARRANTY PROCEDURES

## GENERAL INSTRUCTION

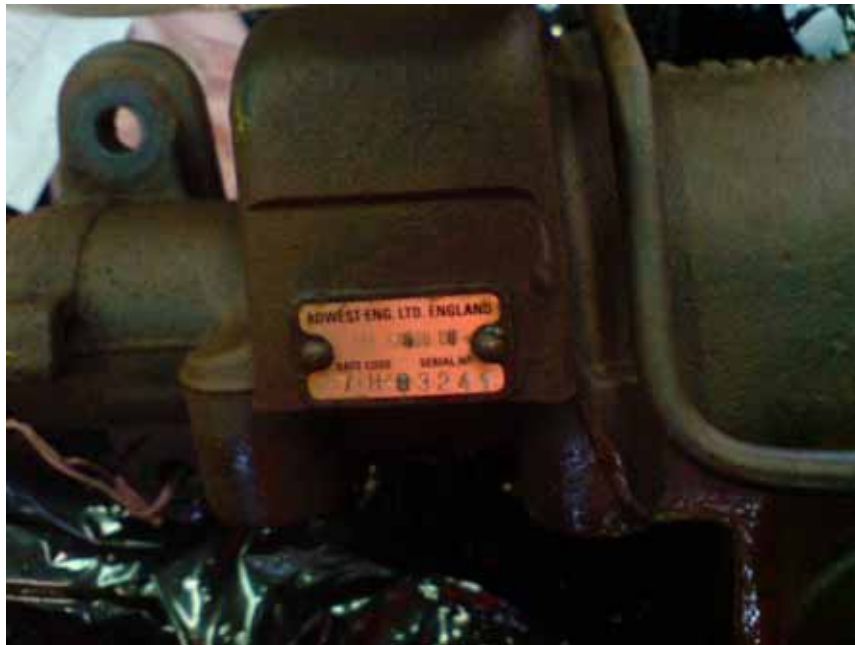
**Figure 1 Serial Number Plate Location**

**10.** The serial number is located either on a plate attached to the box (Figure 1) or stamped on the body for a PAS box refurbished in the UK (Figure 2).

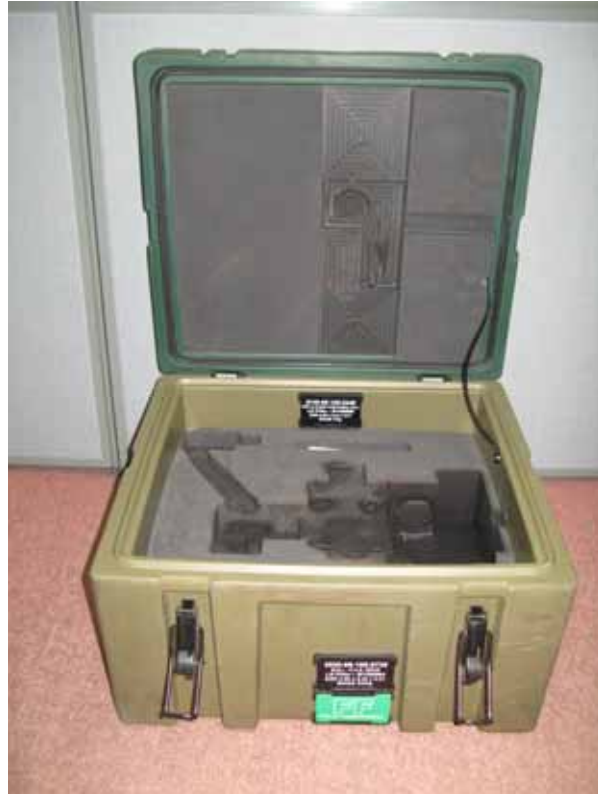
**Figure 3 Trimcast Case**

12. The PAS box is supplied in a Trimcast case, NIIN 66-155-0446 (Figure 3), for transit purposes.

- a. AQIS approved high density foam inserts;
- b. a document pocket for the TI or other shipping documents; and
- c. 3 double-sided tags located on the outside of the case or in a storage clip inside the case as follows:
  - (1) a useability tag with the useability code – ‘SV’ on one side and ‘XX’ on the other side;
  - (2) an identification tag for a Trimcast case complete with a PAS box on one side and for an empty Trimcast case on the other; and
  - (3) an identification tag for a Trimcast case complete with a manual steering box on one side and for an empty Trimcast case on the other.

**14. Care and Maintenance.** The Trimcast case is of a robust design and should provide a long service life if the case is maintained. Regular care includes:

- a. ensuring that 'RP' (repairable) PAS boxes are clean and drained of all oil prior to shipping;
- b. cleaning the foam insert to remove oil and dirt residue;
- c. cleaning the external surface to remove oil, grease and dirt;
- d. inspecting the case catch operation;
- e. inspecting the foam insert for deterioration; and
- f. ensuring that the tags are attached in the pockets provided.
